Maintenance Rating Program

Triangle Expressway

2021 Second Quarter Report

NCTA Triangle Expressway Roadway Maintenance Performance Rating Program; Q2, FY 2021 Rating

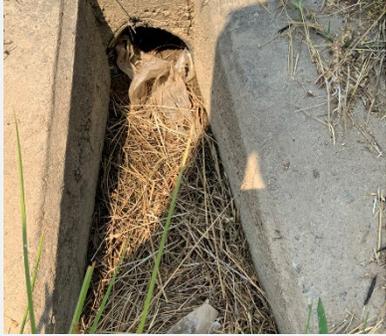
A8
2	Shoulder Drain	MDP_30	Rodent Screen

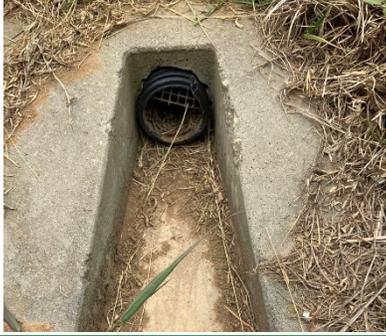
A10
3	Shoulder Drain	MDP_115	Rodent Screen

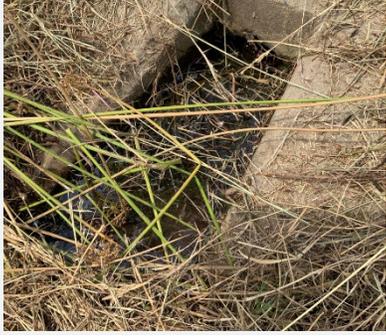
A21
4	Shoulder Drain	MDP_225	Obstruction

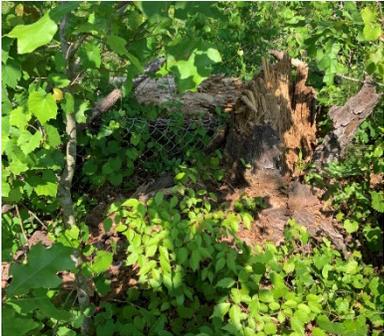
A2
2	Woven	FN_251	Fence Height

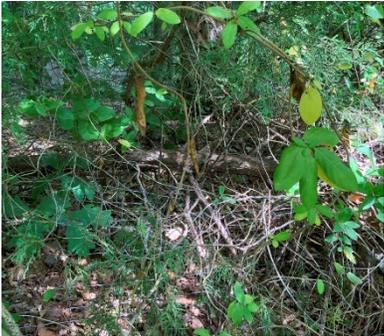
A31
3	Woven	FN_438	Fence Height

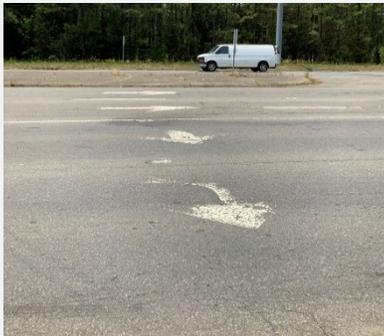
A1
2	Right Turn	PS_413	Daytime Assessment & Nighttime Reflectivity

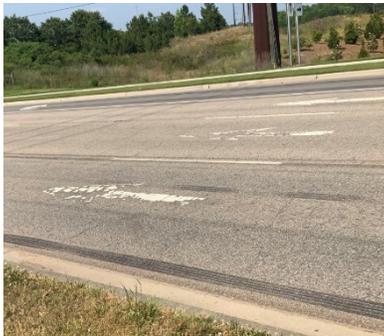
A1
3	Thru Lane	PS_442	Daytime Assessment & Nighttime Reflectivity

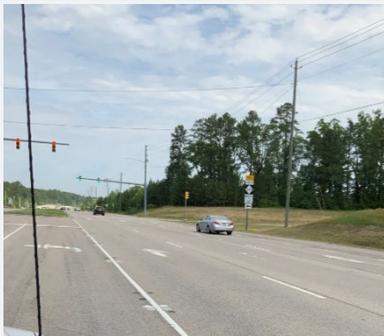
A6
4	Thru Lane	PS_459	Daytime Assessment & Nighttime Reflectivity

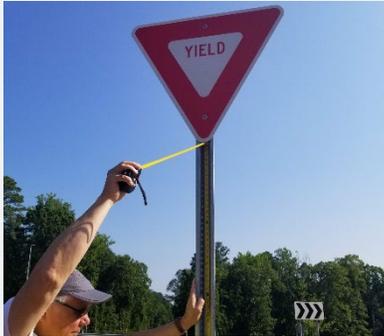
A24
2	Yield	SN_1173	Height Requirement

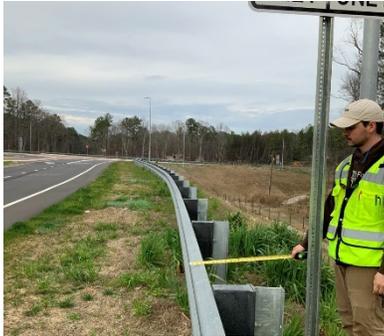
A10
3	Curve	SN_1194	Lateral Clearance

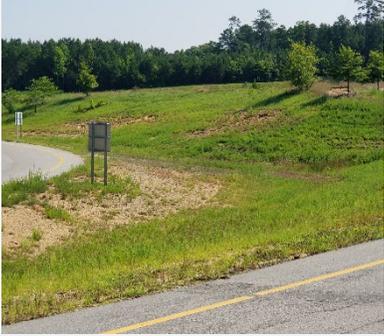
A22
2	Turf	TF_1014	Bare Ground

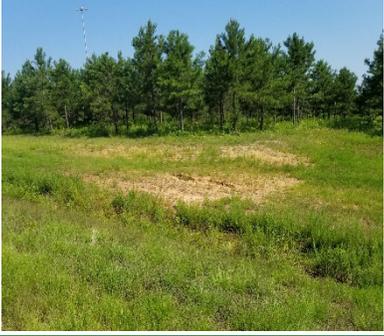
A28
3	Turf	TF_1018	Bare Ground
