# Maintenance Rating Program

Triangle Expressway

2021 Third Quarter Report

### NCTA Triangle Expressway Roadway Maintenance Performance Rating Program; Q3, FY 2021 Rating

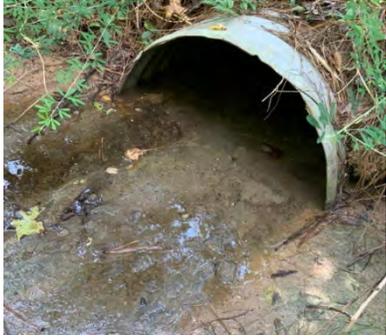
#	Material Type	Object ID	Failure Type	Photo	GIS Reference Page
1	Drain	DP_236	Obstruction

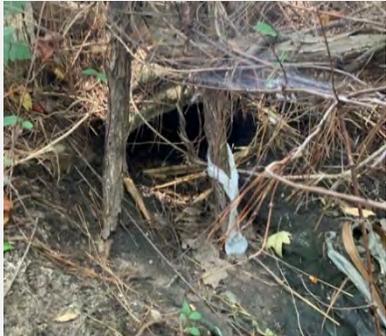
A11
2	Drain	DP_432	Obstruction

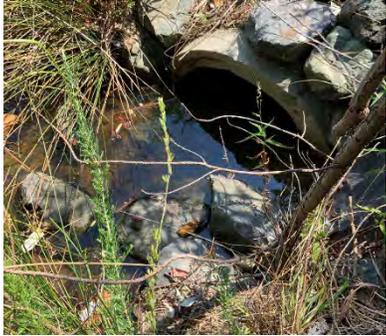
A5
3	Drain	DP_992	Obstruction

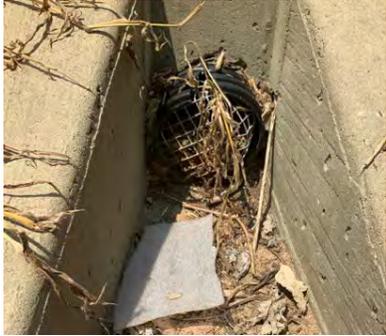
#	Material Type	Object ID	Failure Type	Photo	GIS Reference Page
1	Shoulder Drain	MDP_32	Obstruction

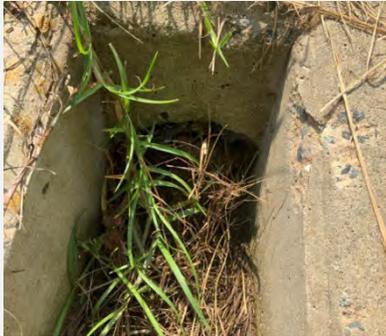
A11
2	Shoulder Drain	MDP_36	Obstruction

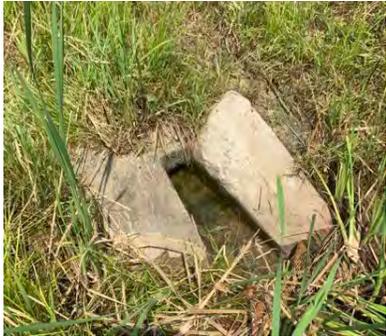
A11
3	Shoulder Drain	MDP_55	Rodent Screen

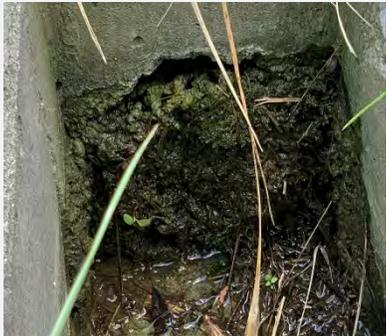
A13
4	Shoulder Drain	MDP_93	Obstruction

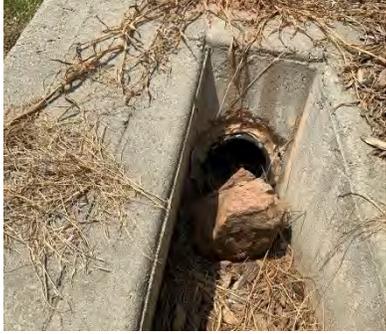
#	Material Type	Object ID	Failure Type	Photo	GIS Reference Page
5	Shoulder Drain	MDP_151	Rodent Screen

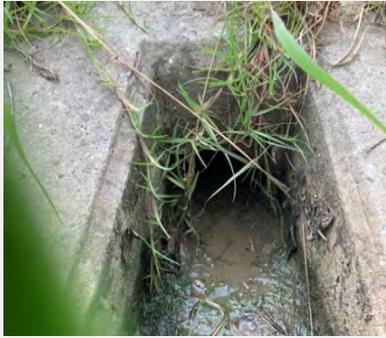
A35
6	Shoulder Drain	MDP_232	Rodent Screen

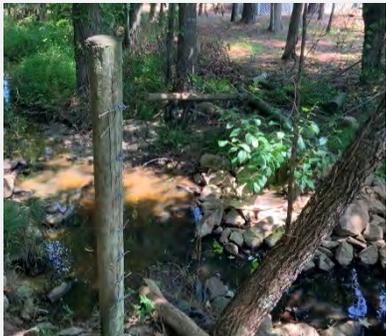
A29
2	Woven	FN_350	Fence Hole

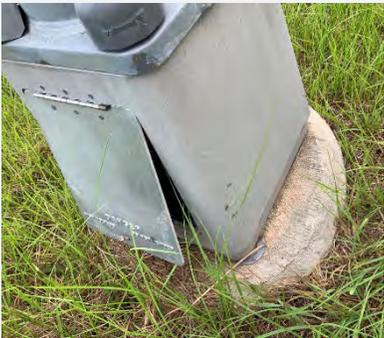
A2
2	Single Roadway	HL_347	Missing Parts

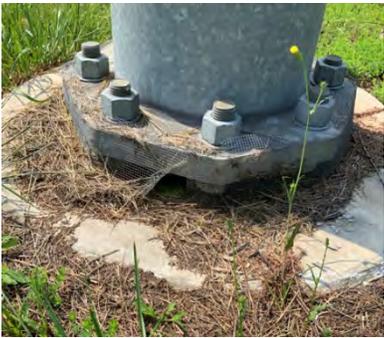
A2
3	High Mast	HL_367	Rodent Screen

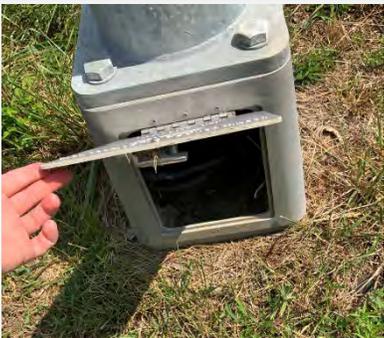
A24
4	Single Roadway	HL_395	Missing Parts

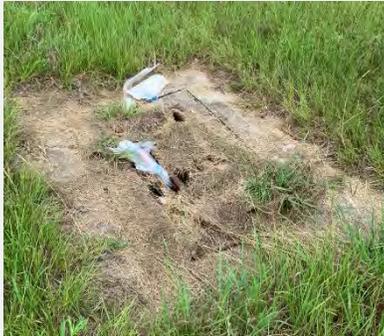
A12
2	Inlet	IN_360	Obstruction

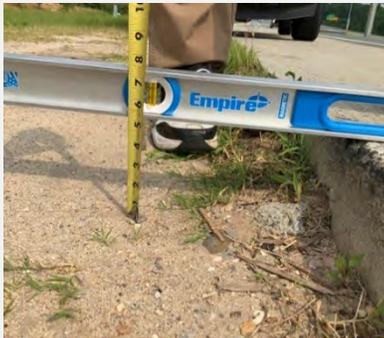
A21
2	Concrete	LS_450	Drop Off

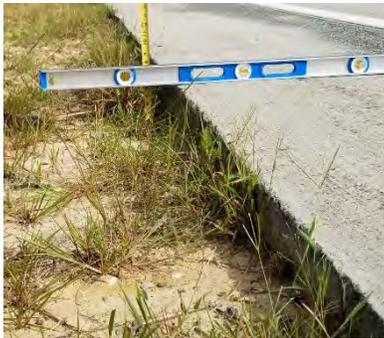
A24
3	Concrete	LS_620	Drop Off

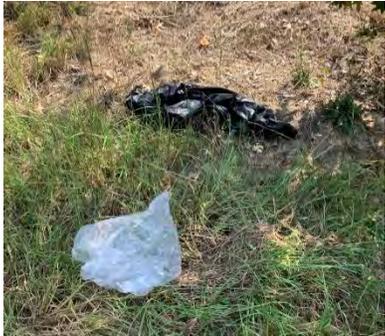
A34
2	Concrete	LS_415	Litter – 3CF

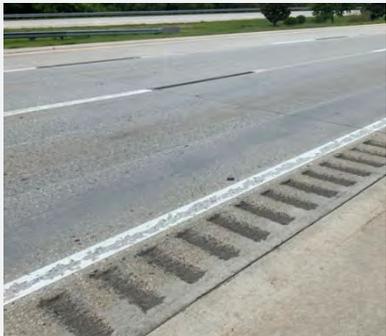
A9
2	Concrete	LS_68	Line Missing

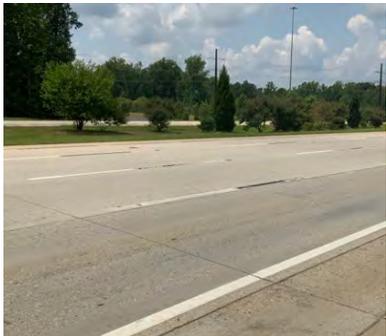
A8
3	Concrete	LS_94	Line Missing, Nighttime Visibility

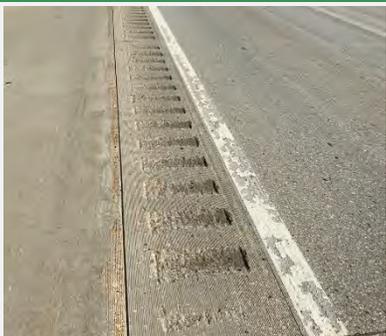
A13
4	Concrete	LS_132	Line Missing

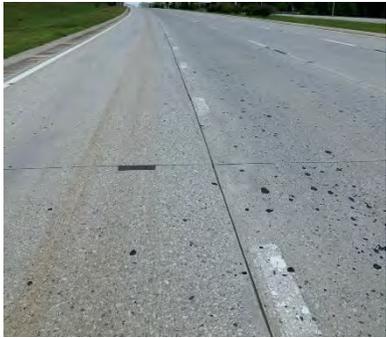
#	Material Type	Object ID	Failure Type	Photo	GIS Reference Page
5	Concrete	LS_160	Line Missing, Nighttime Visibility

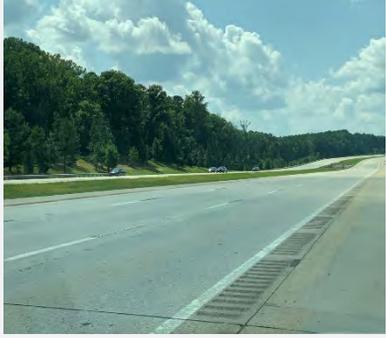
A13
6	Concrete	LS_161	Line Missing, Nighttime Visibility

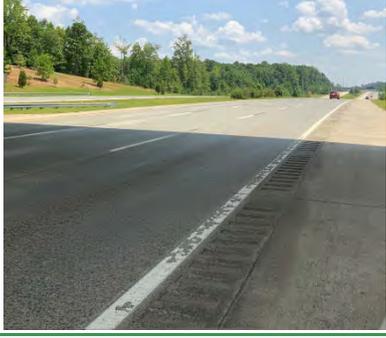
A14
7	Concrete	LS_419	Line Missing

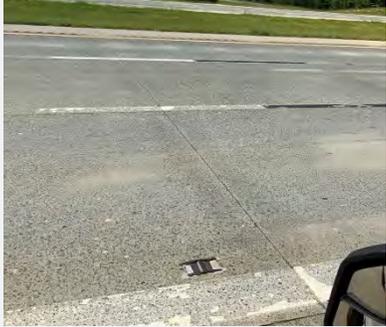
A21
8	Concrete	LS_437	Line Missing, Nighttime Visibility

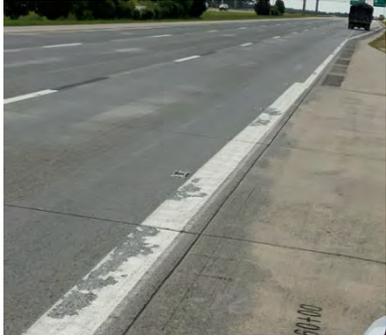
#	Material Type	Object ID	Failure Type	Photo	GIS Reference Page
9	Concrete	LS_450	Line Width

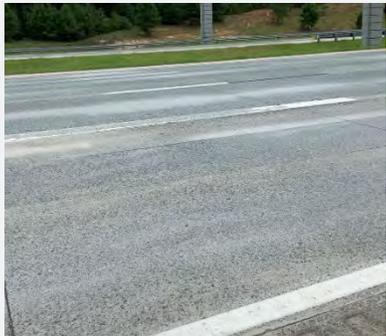
A24
10	Concrete	LS_622	Line Missing

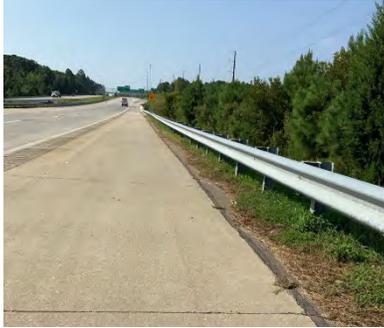
#	Material Type	Object ID	Failure Type	Photo	GIS Reference Page
1	Concrete	LS_41	Missing

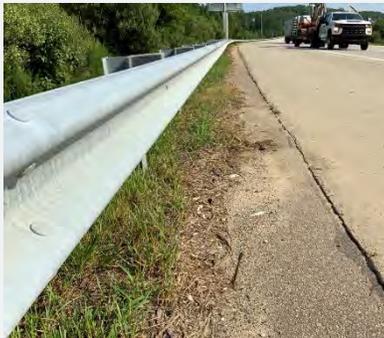
A9
2	Concrete	LS_132	Missing

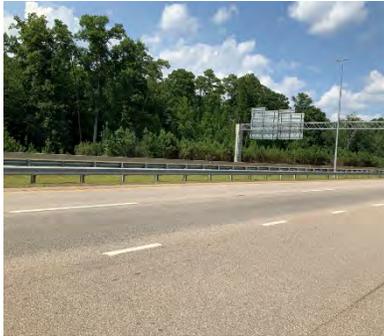
A8
3	Asphalt	LS_367	Missing

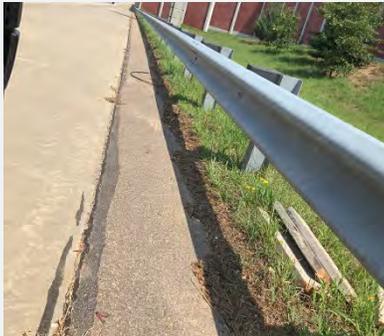
A26
4	Concrete	LS_415	Missing

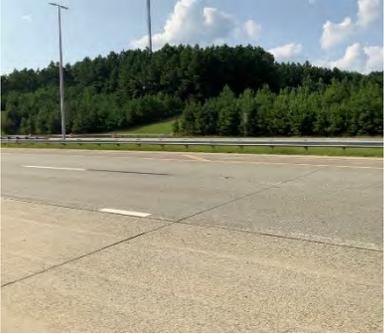
#	Material Type	Object ID	Failure Type	Photo	GIS Reference Page
5	Concrete	LS_469	Missing

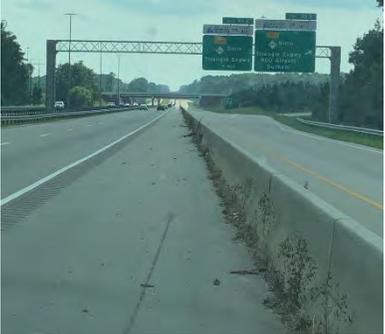
A28
6	Asphalt	LS_523	Missing & Nighttime Reflectivity

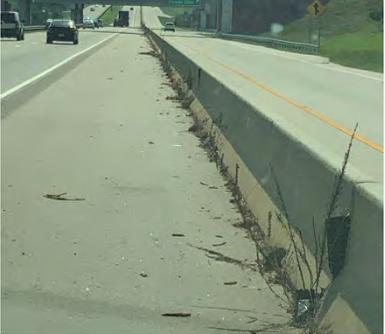
A26
7	Asphalt	LS_528	Missing & Nighttime Reflectivity

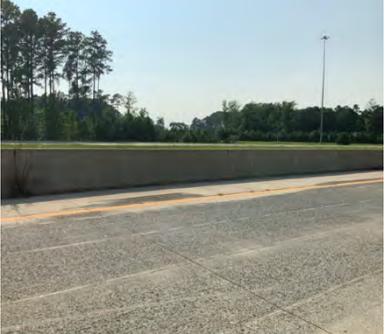
A24
8	Concrete	LS_673	Missing

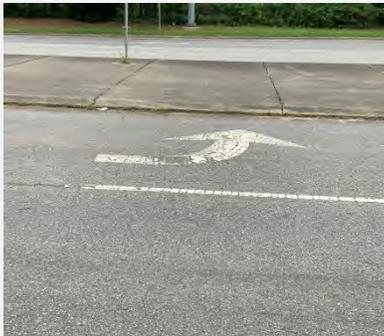
A13
2	Left Turn	PS_415	Nighttime Reflectivity

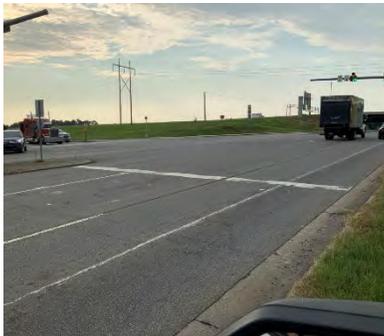
A1
3	Stop Bar	PS_427	Daytime Assessment & Nighttime Reflectivity

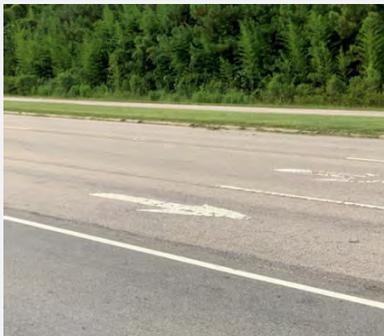
A1
4	Thru Lane	PS_444	Daytime Assessment & Nighttime Reflectivity

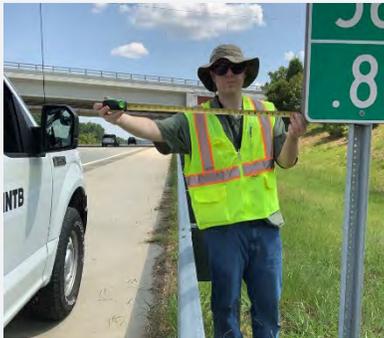
A34
2	Mile Post	SN_735	Lateral Clearance

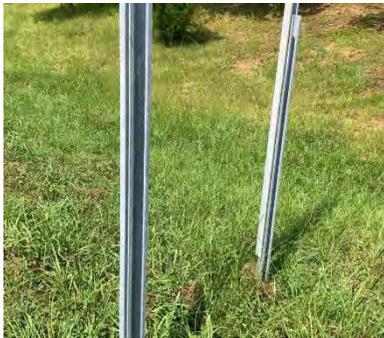
A22
3	Other	SN_1029	Sign Support

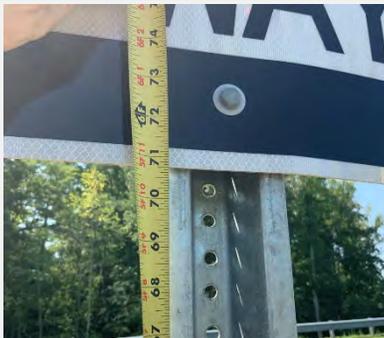
A35
4	Wrong Way	SN_1208	Height Requirement

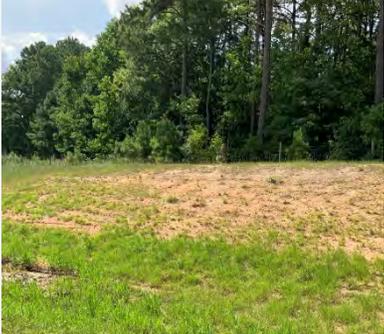
A17
2	Turf	TF_169	Bare Ground

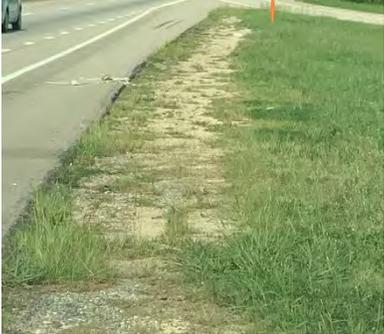
A25
3	Turf	TF_172	Bare Ground

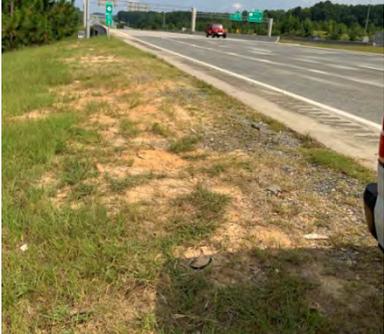
A24
4	Turf	TF_237	Bare Ground

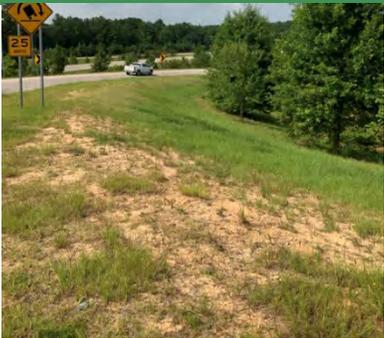
#	Material Type	Object ID	Failure Type	Photo	GIS Reference Page
5	Turf	TF_240	Bare Ground

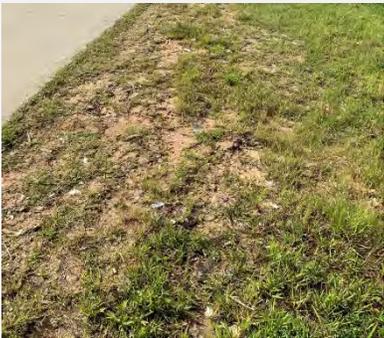
A24
6	Turf	TF_245	Bare Ground

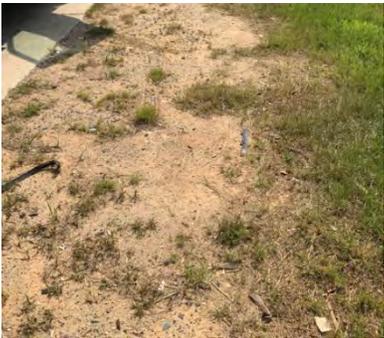
A10
7	Turf	TF_324	Bare Ground

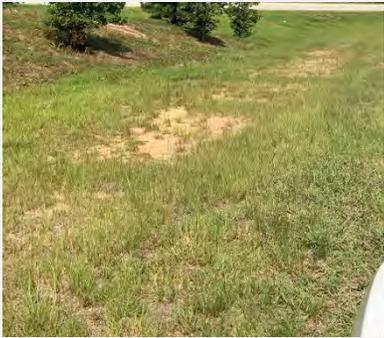
A28
8	Turf	TF_425	Bare Ground

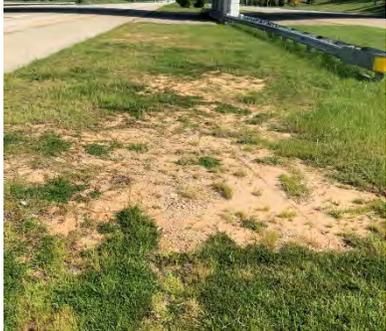
#	Material Type	Object ID	Failure Type	Photo	GIS Reference Page
9	Turf	TF_656	Bare Ground

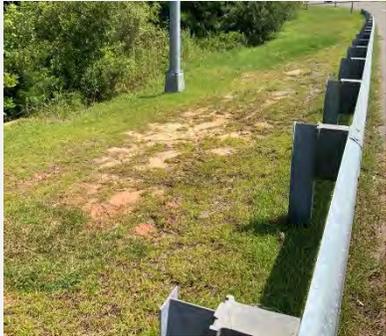
A13
10	Turf	TF_844	Bare Ground

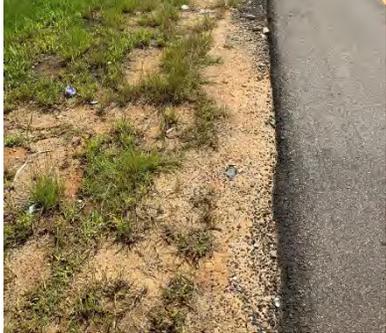
A35
11	Turf	TF_1016	Bare Ground

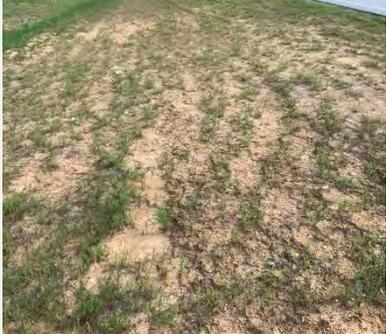
A28
12	Turf	TF_1023	Bare Ground

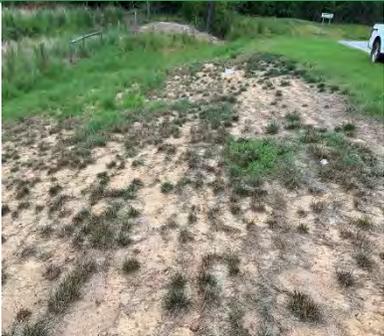
#	Material Type	Object ID	Failure Type	Photo	GIS Reference Page
13	Turf	TF_1036	Bare Ground

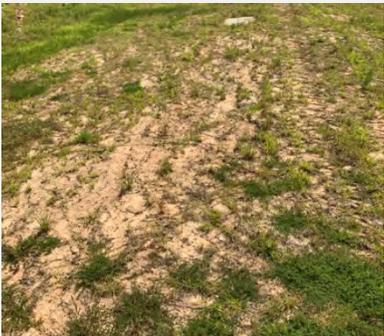
A28
14	Turf	TF_1044	Bare Ground

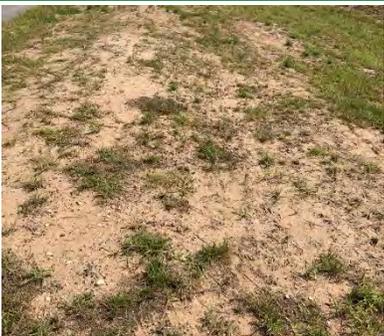
A10
15	Turf	TF_1077	Bare Ground

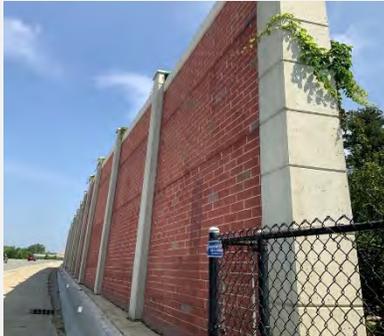
A34
2	Sound Wall	WL_46	Unsealed Cracks/Joints, Vegetation

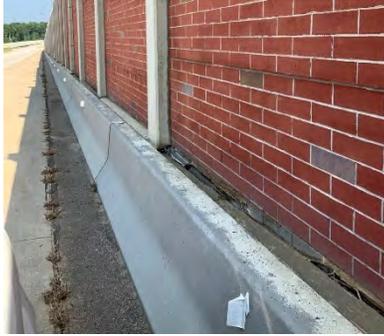
A19
3	Sound Wall	WL_98	Unsealed Cracks/Joints

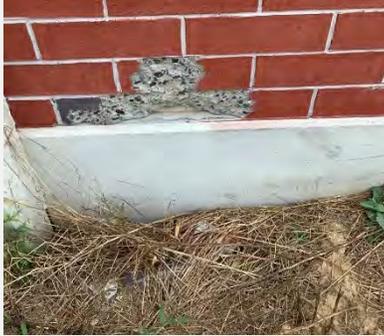
A20
4	Sound Wall	WL_102	Spalling

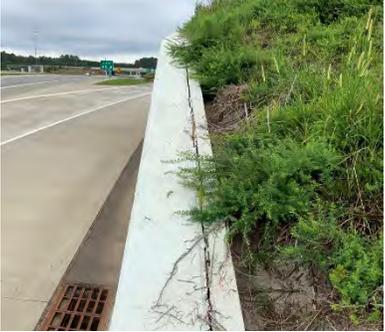
#	Material Type	Object ID	Failure Type	Photo	GIS Reference Page
5	Retaining Wall	WL_116	Unsealed Joints/Cracks
