# Maintenance Rating Program

Triangle Expressway

2021 Fourth Quarter Report

### NCTA Triangle Expressway Roadway Maintenance Performance Rating Program; Q4, FY 2021 Rating

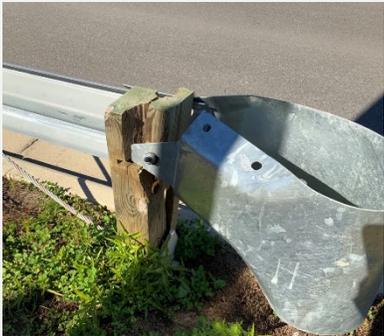
A26
2	Guardrail	BR_804	Functional Damage

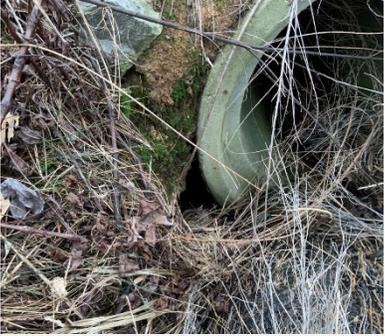
A7
2	Drain	DP_766	Erosion

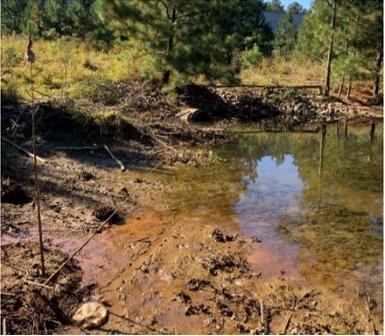
A25
3	Drain	DP_908	Obstruction

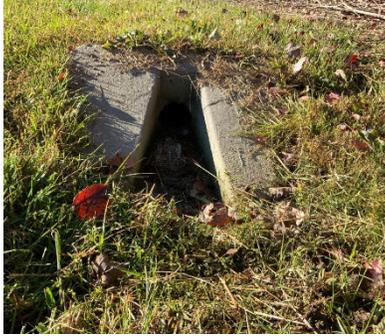
A16
2	Shoulder Drain	MDP_70	Obstruction & Rodent Screen

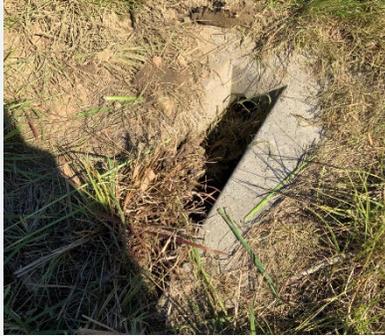
A16
3	Shoulder Drain	MDP_144	Obstruction & Rodent Screen

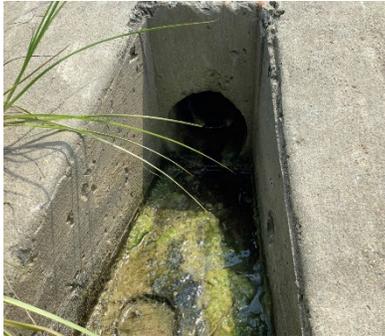
A25
4	Shoulder Drain	MDP_149	Rodent Screen

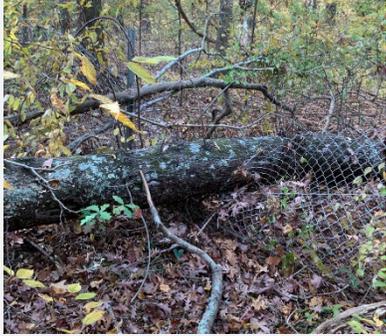
A6
2	Chain Link	FN_249	Hole Height

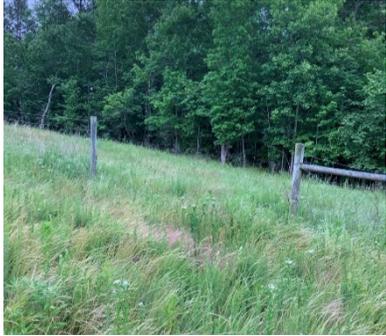
A31
3	Woven	FN_305	Fence Hole

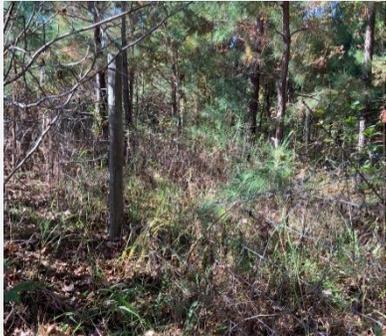
A5
4	Woven	FN_382	Fence Hole

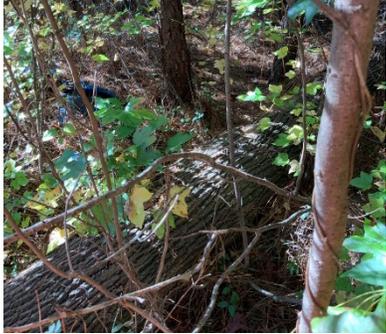
#	Material Type	Object ID	Failure Type	Photo	GIS Reference Page
5	Woven	FN_408	Hole Height

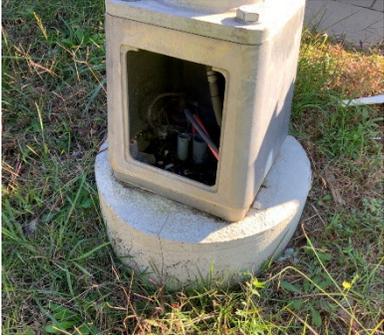
#	Material Type	Object ID	Failure Type	Photo	GIS Reference Page
1	Single Roadway	HL_8	Missing Parts

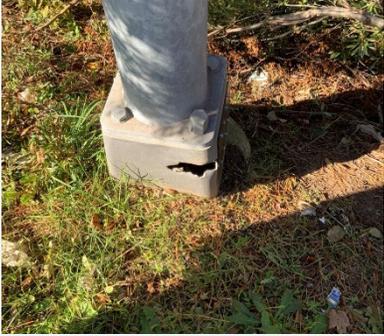
A30
2	Single Roadway	HL_52	Missing Parts

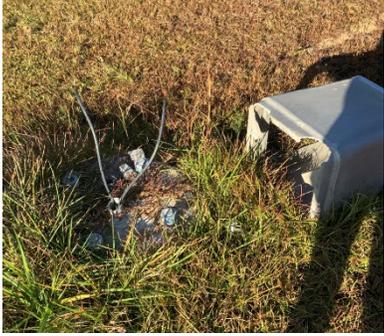
A8
3	Single Roadway	HL_78	Part Damage

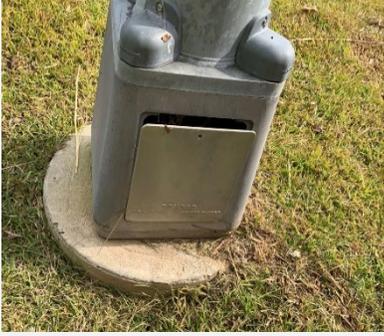
A14
4	Single Roadway	HL_125	Missing Parts

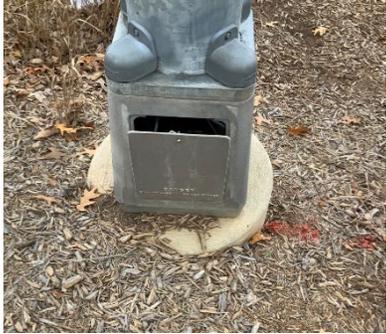
#	Material Type	Object ID	Failure Type	Photo	GIS Reference Page
5	Single Roadway	HL_240	Missing Parts

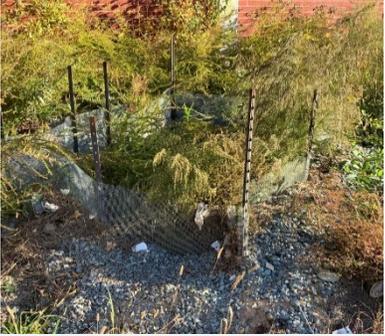
A18
2	Inlet	IN_712	Obstruction

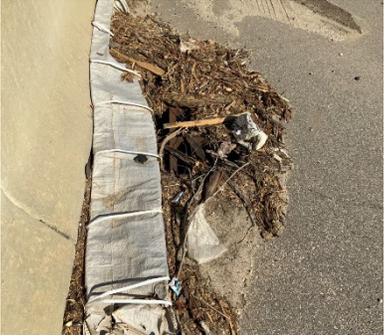
A20
3	Inlet	IN_763	Obstruction

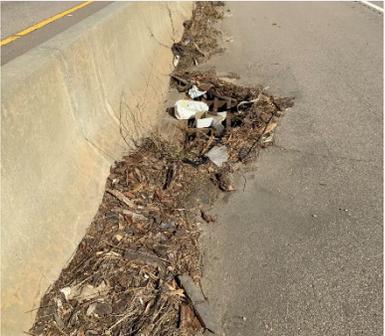
A26
4	Inlet	IN_784	Obstruction

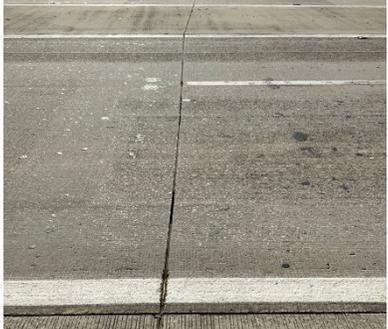
#	Material Type	Object ID	Failure Type	Photo	GIS Reference Page
1	Concrete	LS_590	Joint Malfunction

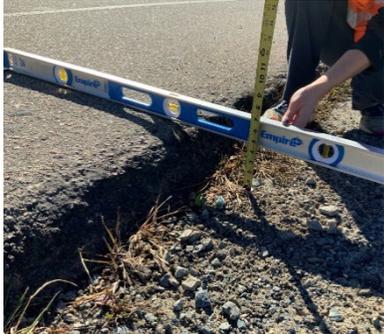
#	Material Type	Object ID	Failure Type	Photo	GIS Reference Page
1	Concrete	LS_545	Drop Off

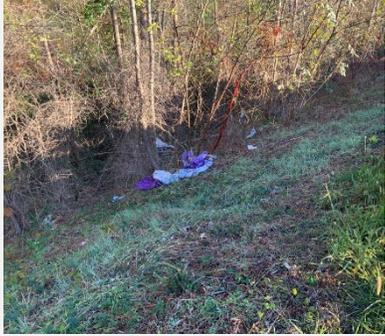
A15
2	Asphalt	LS_225	Litter – 3CF

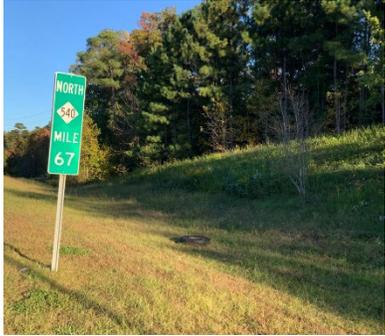
A3
3	Concrete	LS_591	Litter – 3CF

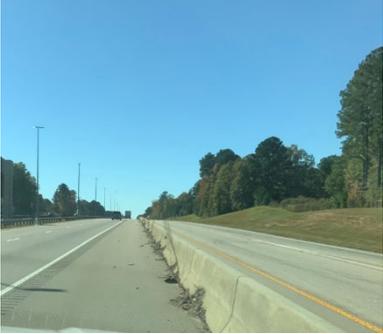
#	Material Type	Object ID	Failure Type	Photo	GIS Reference Page
1	Asphalt	LS_534	Material Accumulation

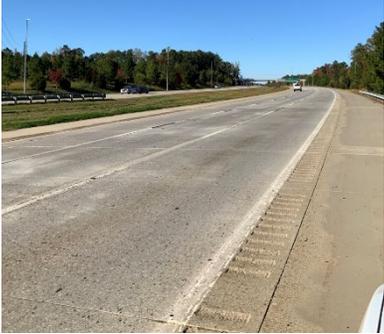
#	Material Type	Object ID	Failure Type	Photo	GIS Reference Page
1	Concrete	LS_42	Line Missing, Nighttime Visibility

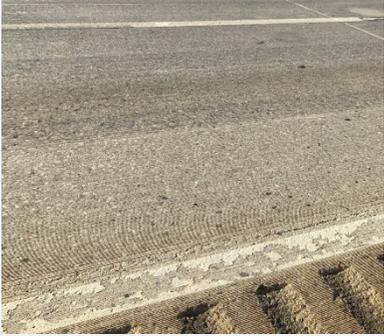
A14
2	Concrete	LS_63	Line Missing, Nighttime Visibility

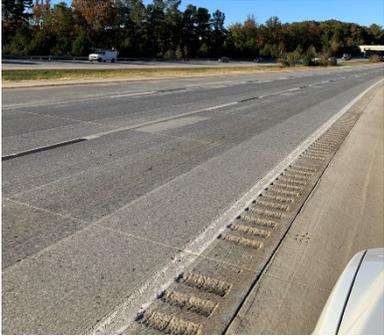
A8
3	Concrete	LS_66	Line Missing, Nighttime Visibility

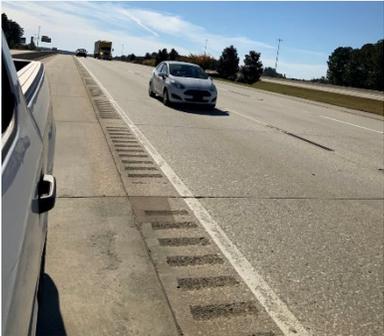
A9
4	Concrete	LS_117	Line Missing

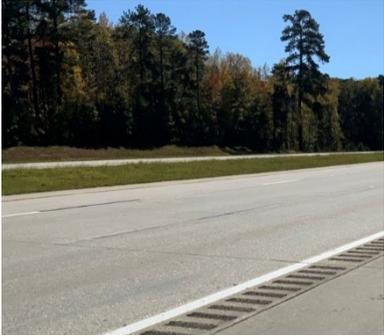
#	Material Type	Object ID	Failure Type	Photo	GIS Reference Page
5	Concrete	LS_138	Line Missing, Nighttime Visibility

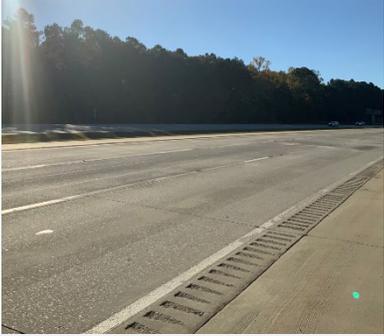
A10
6	Concrete	LS_165	Line Missing, Nighttime Visibility

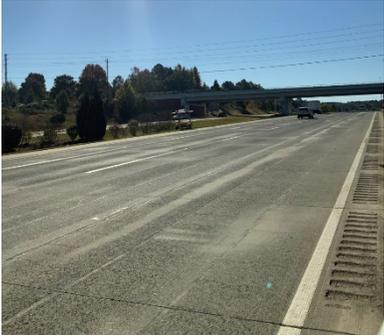
A15
7	Concrete	LS_403	Line Missing, Nighttime Visibility

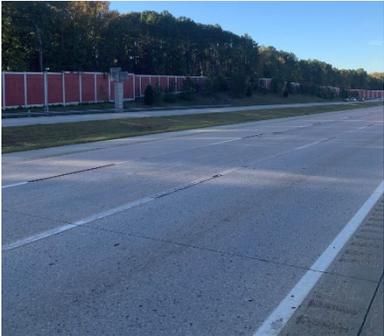
A20
8	Concrete	LS_413	Line Missing, Nighttime Visibility

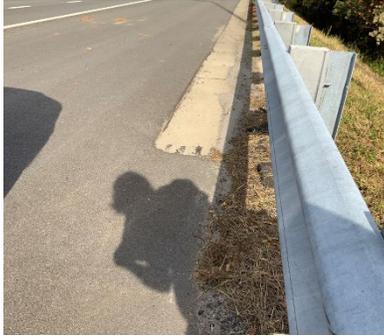
#	Material Type	Object ID	Failure Type	Photo	GIS Reference Page
1	Asphalt	LS_250	Missing, Nighttime Reflectivity

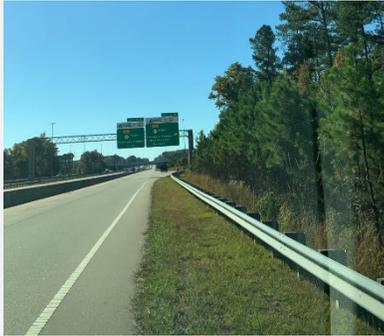
A33
2	Asphalt	LS_343	Nighttime Reflectivity	Not Available for Nighttime Failure	A5
3	Concrete	LS_386	Missing, Nighttime Reflectivity

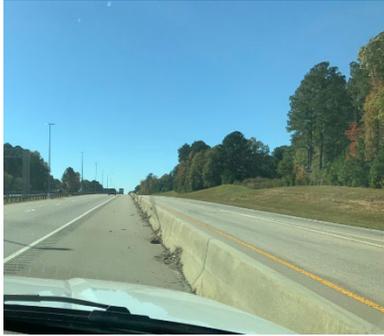
A27
4	Asphalt	LS_534	Missing, Nighttime Reflectivity

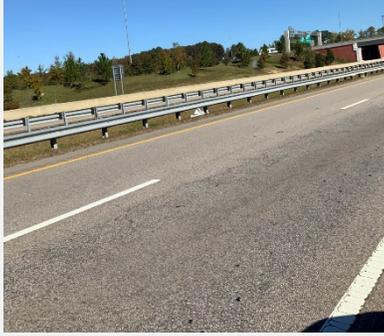
A26
5	Asphalt	LS_535	Missing, Nighttime Reflectivity

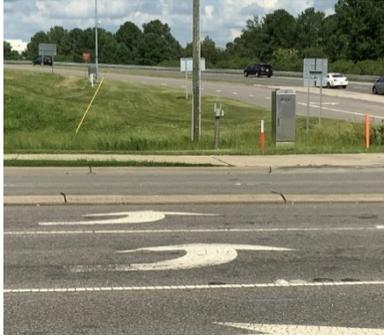
#	Material Type	Object ID	Failure Type	Photo	GIS Reference Page
1	Left Turn	PS_409	Daytime Assessment & Nighttime Reflectivity

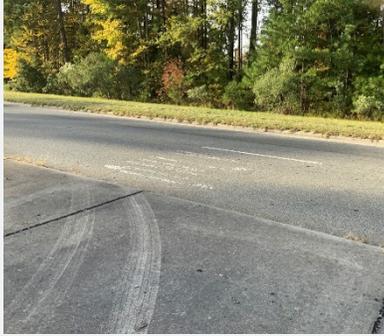
A1
2	Only	PS_420	Daytime Assessment & Nighttime Reflectivity

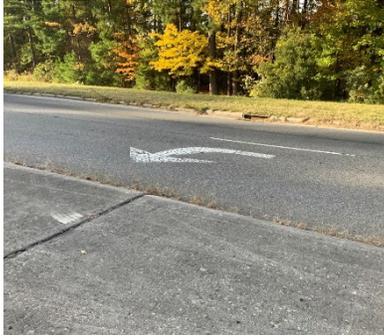
A1
3	Left Turn	PS_421	Daytime Assessment & Nighttime Reflectivity

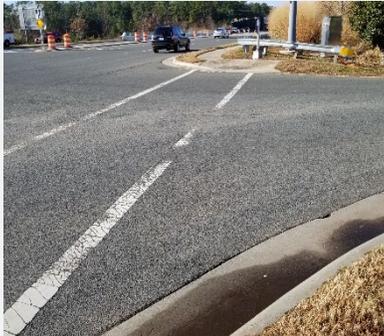
A1
4	Ped Xing	PS_527	Daytime Assessment & Nighttime Reflectivity

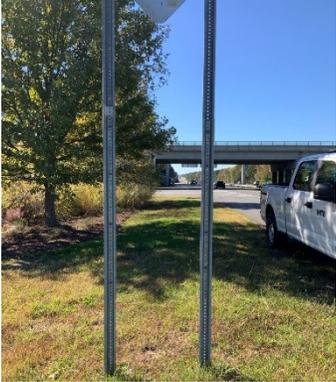
#	Sign Type	Object ID	Failure Type	Photo	GIS Reference Page
1	Merge	SN_185	Height Requirement, Sign Support

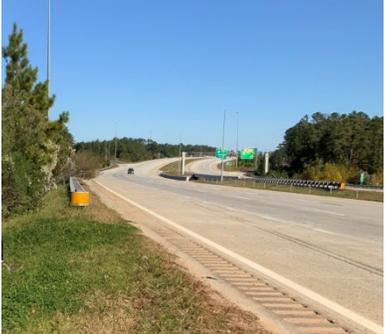
#	Material Type	Object ID	Failure Type	Photo	GIS Reference Page
1	Tree and Brush	TB_564	Barrier Clearance

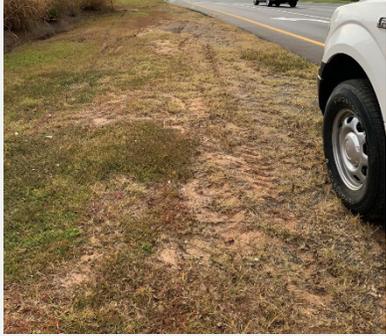
A8
2	Turf	TF_256	Bare Ground

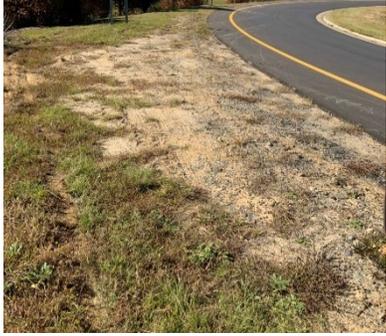
A34
3	Turf	TF_379	Bare Ground
