Maintenance Rating Program

Triangle Expressway

May 2022

2022 First Quarter Report

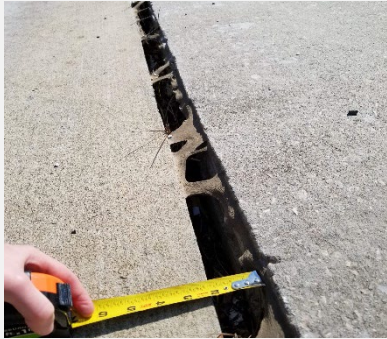
A10
2	Shoulder Berm Gutter	CG_68	Separation

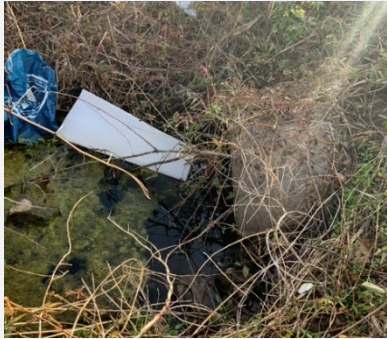
A7
2	Drain	DP_452	Obstruction

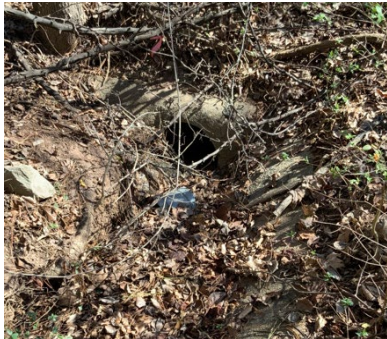
A3
3	Drain	DP_658	Obstruction

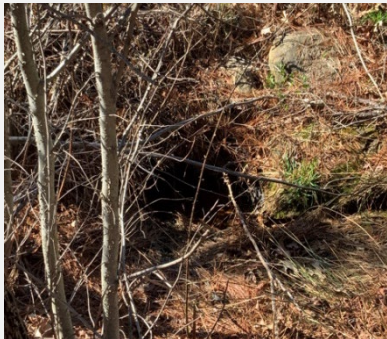
A31
4	Drain	DP_1045	Obstruction

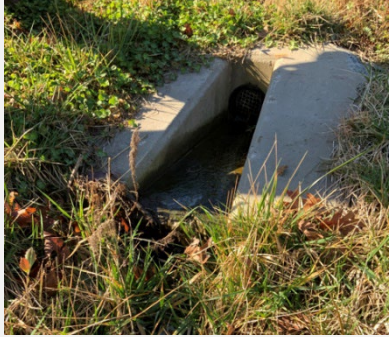
A20
2	Shoulder Drain	MDP_156	Obstruction

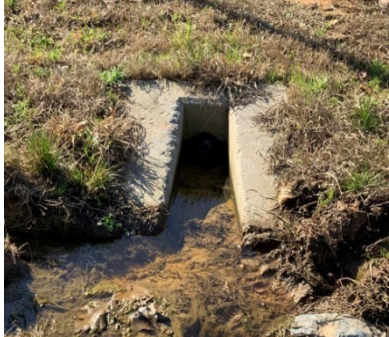
A28
3	Shoulder Drain	MDP_165	Obstruction

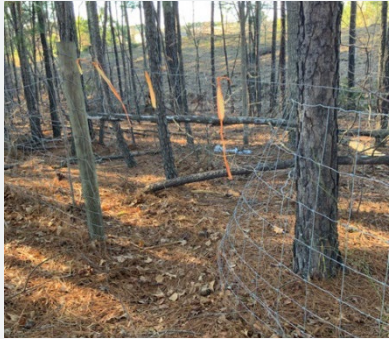
A12
2	Woven	FN_310	Hole Height

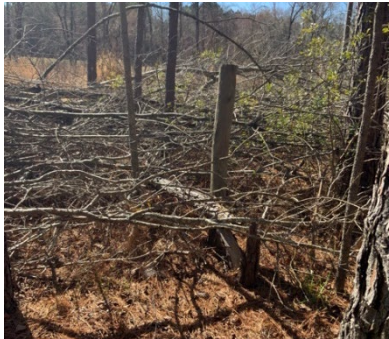
A1
3	Woven	FN_494	Fence Hole

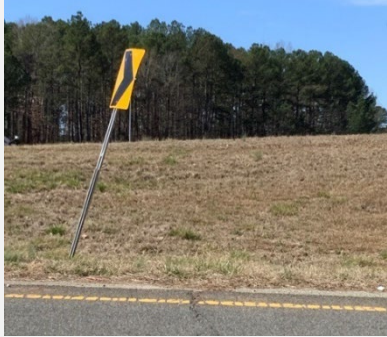
A1
2	Chevron	SN_1049	Leaning

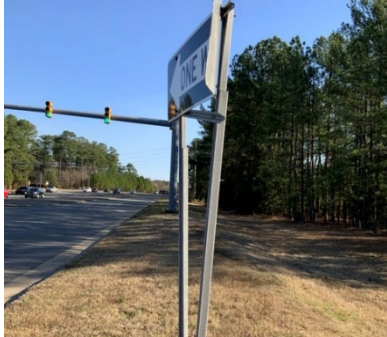
A31
3	One Way	SN_1114	Support, Leaning

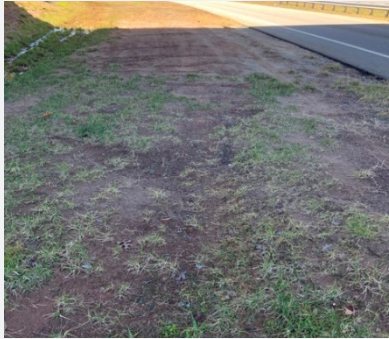
A23
2	Turf	TF_956	Bare Ground

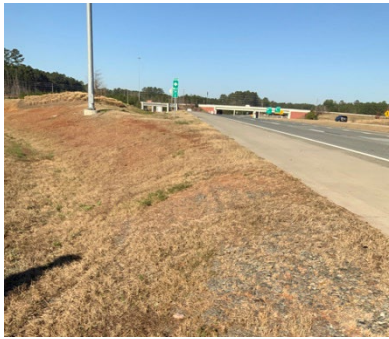
A31
3	Turf	TF_1017	Bare Ground
