# Maintenance Rating Program

## Triangle Expressway

2022 Second Quarter Report

### NCTA Triangle Expressway Roadway Maintenance Performance Rating Program; Q2, FY 2022 Rating

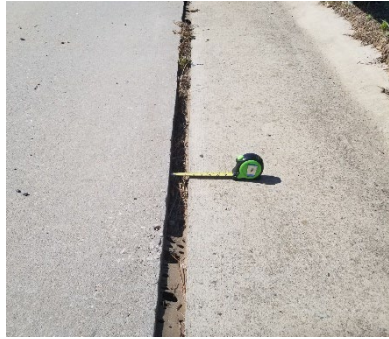
A30
2	Shoulder Berm Gutter	CG_57	Separation

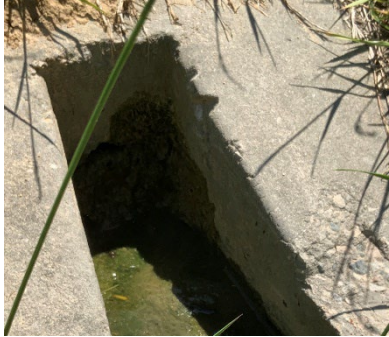
A14
2	Shoulder Drain	MDP_93	Obstruction

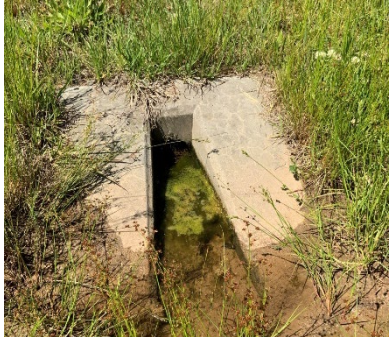
A19
3	Shoulder Drain	MDP_157	Obstruction

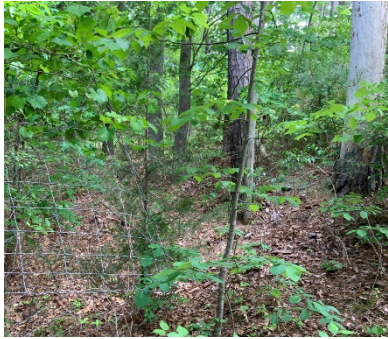
A6
2	Woven	FN_215	Hole Height

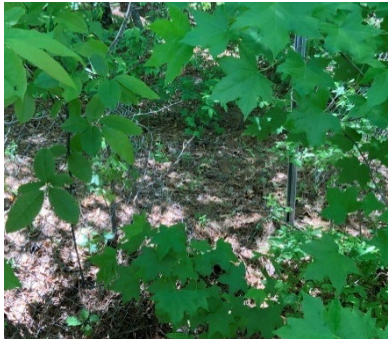
A3
3	Woven	FN_286	Fence Hole

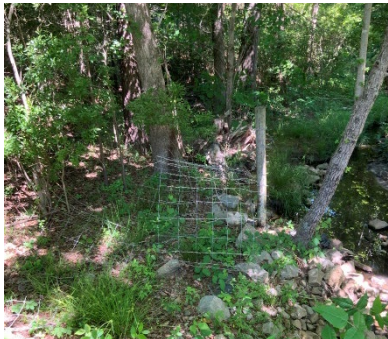
A35
4	Woven	FN_350	Fence Hole

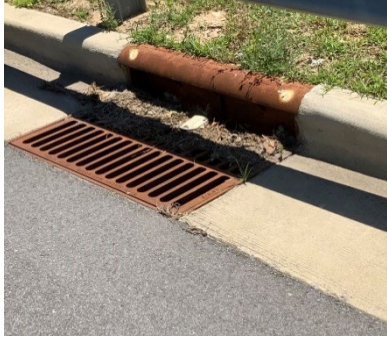
A20
2	Inlet	IN_1122	Obstruction

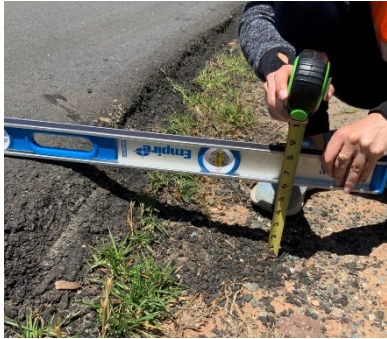
A29
2	Asphalt	LS_238	Drop Off

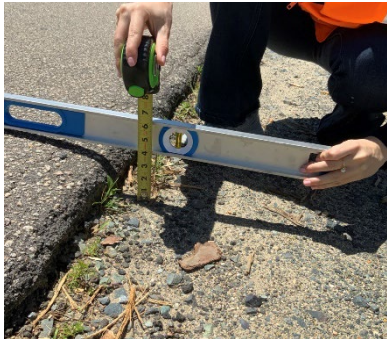
A35
3	Asphalt	LS_544	Drop Off

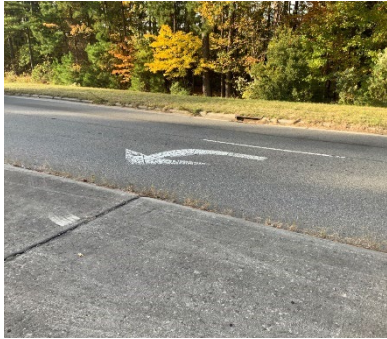
A1
2	Left Turn	PS_421	Nighttime Reflectivity

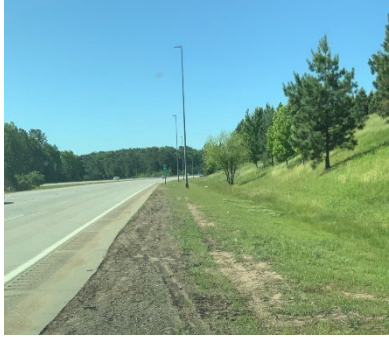
A18
6	Turf	TF_565	Bare Ground

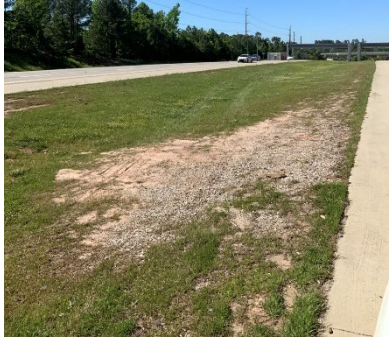
A14
7	Turf	TF_647	Bare Ground

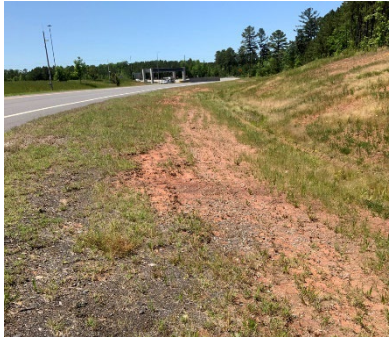
A8
8	Turf	TF_1039	Bare Ground
