Maintenance Rating Program

Triangle Expressway

2022 Fourth Quarter Report

NCTA Triangle Expressway Roadway Maintenance Performance Rating Program; Q4, CY 2022 Rating

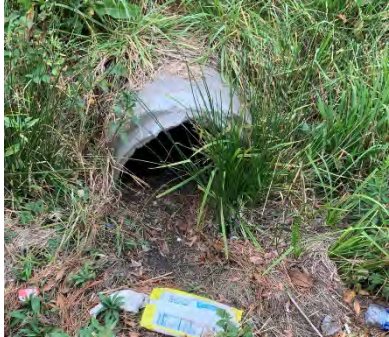
A1
2	Drain	DP_408	Obstruction

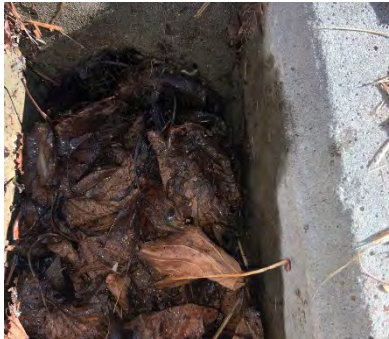
A19
2	Shoulder Drain	MDP_118	Rodent Screen, Obstruction

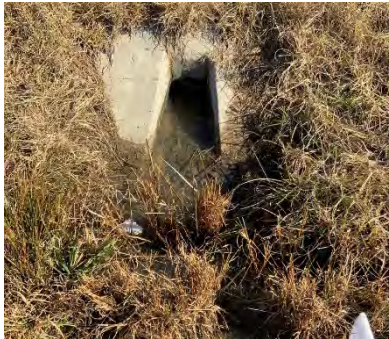
A19
3	Shoulder Drain	MDP_141	Obstruction

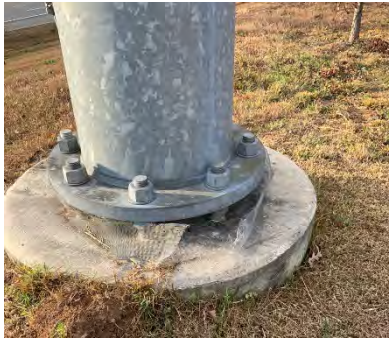
A28
2	High Mast	HL_203	Rodent Screen

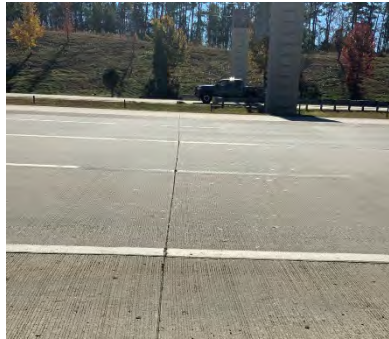
A4
2	Concrete	LS_343	Joint Malfunction

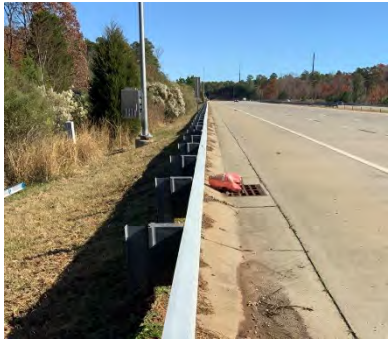
A32
2	Concrete	LS_342	Litter

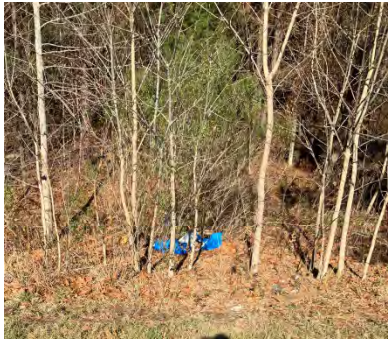
A4
3	Concrete	LS_343	Litter

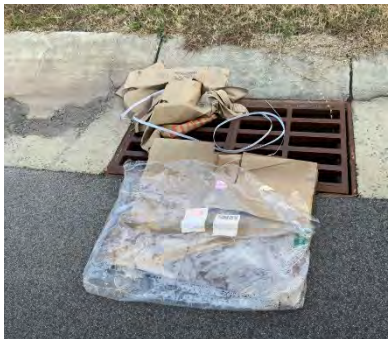
A4
4	Asphalt	LS_768	Litter

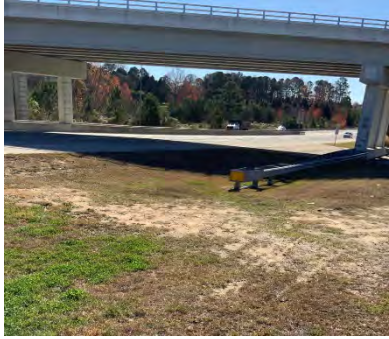
A18
6	Turf	TF_665	Bare Ground
