# Maintenance Rating Program

Triangle Expressway

2023 First Quarter Report

### NCTA Triangle Expressway Roadway Maintenance Performance Rating Program; Q1, FY 2023 Rating

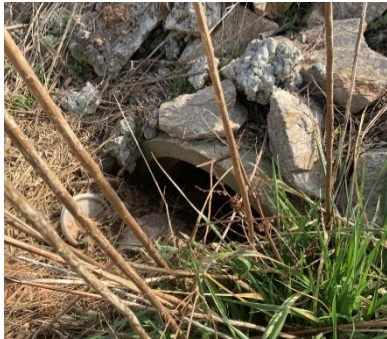
A12
2	Drain	DP_709	Obstruction

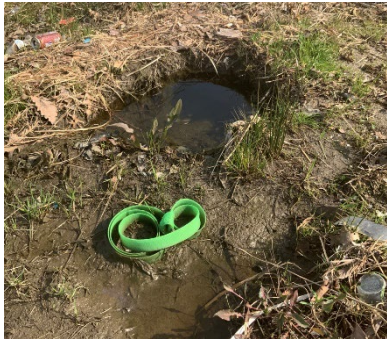
A2
3	Drain	DP_788	Obstruction

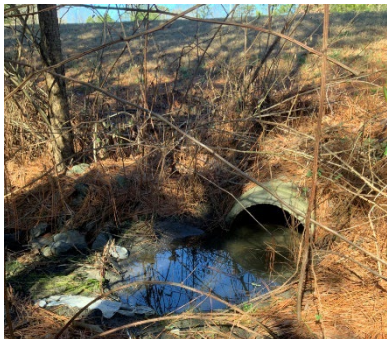
A23
4	Drain	DP_860	Obstruction

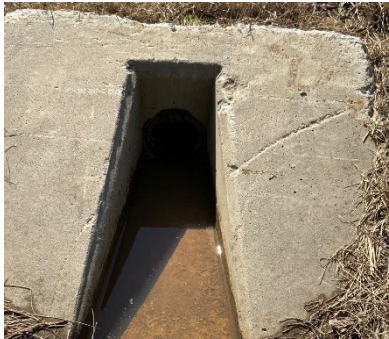
A12
3	Shoulder Drain	MDP_158	Rodent Screen

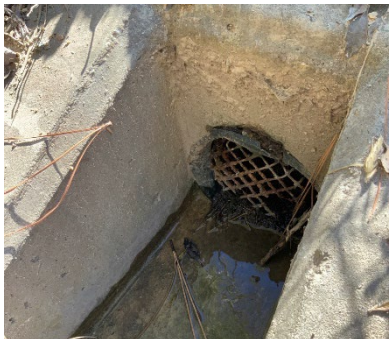
A26
4	Shoulder Drain	MDP_169	Rodent Screen

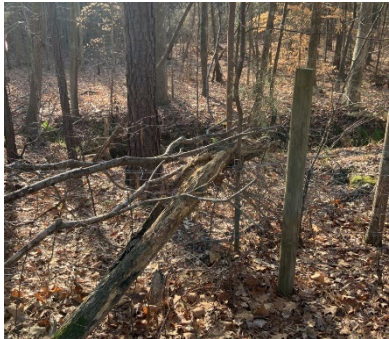
A5
2	Woven	FN_217	Height

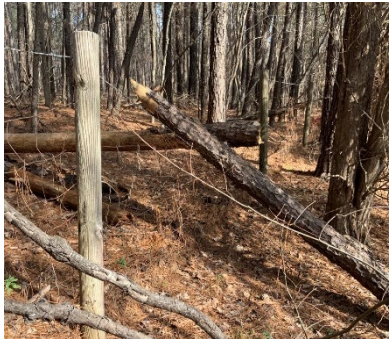
A2
3	Woven	FN_248	Height

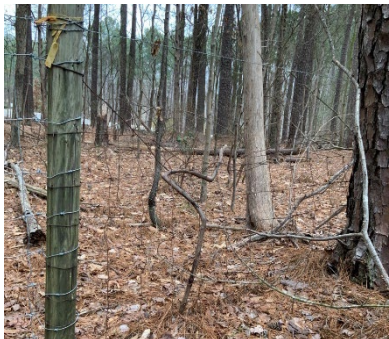
A29
4	Woven	FN_301	Fence Hole

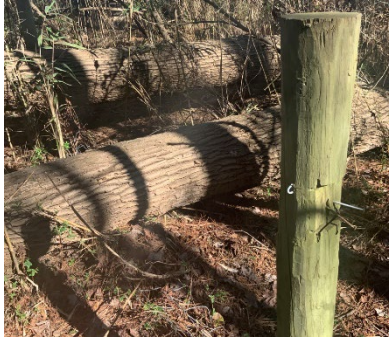
A1
6	Woven	FN_328	Height

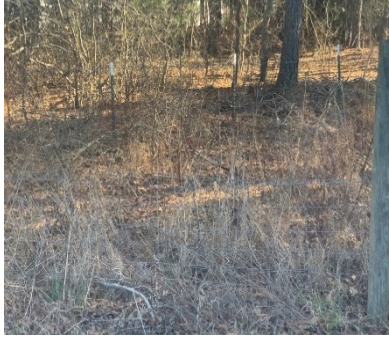
A16
7	Woven	FN_356	Height

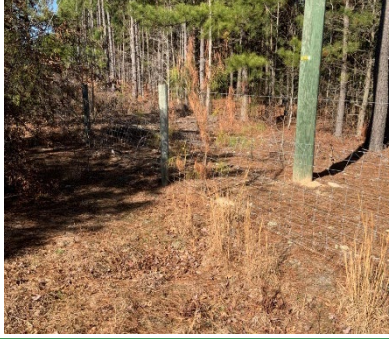
A15
8	Woven	FN_486	Fence Hole

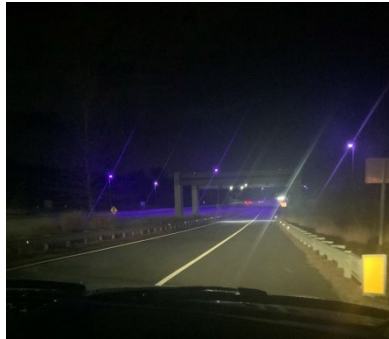
A12
2	Asphalt	LS_242	Nighttime Reflectivity
