Maintenance Rating Program

Triangle Expressway

2023 Third Quarter Report

NCTA Monroe By-Pass Roadway Maintenance Performance Rating Program; Q3, FY 2023 Rating

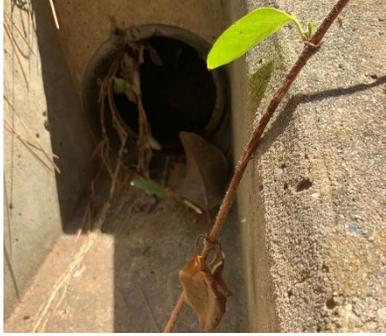
A10
3	Shoulder Drain	MDP_40	Rodent Screen

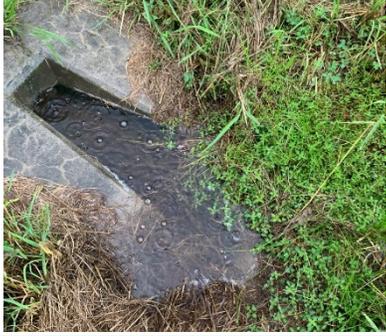
A11
4	Shoulder Drain	MDP_157	Obstruction

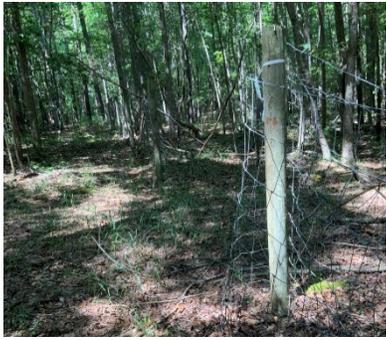
A11
2	Woven	FN_400	Hole

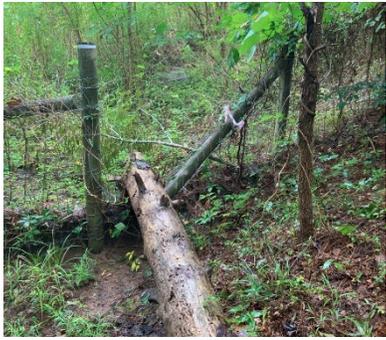
A24
3	Woven	FN_462	Height

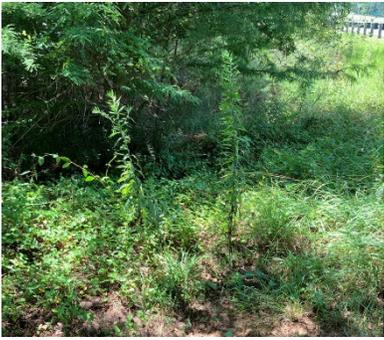
A12
2	Plant Bed	PB_258	Weeds

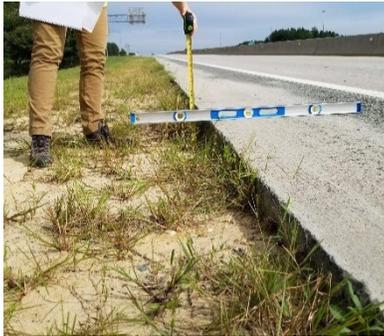
A24
2	Concrete	LS_620	Drop off

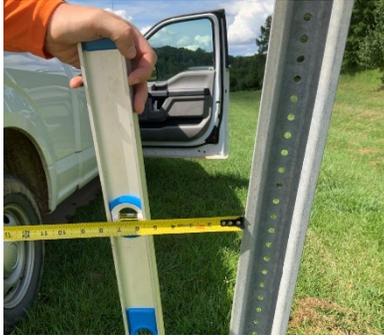
A25
2	Mile Post	SN_231	Leaning

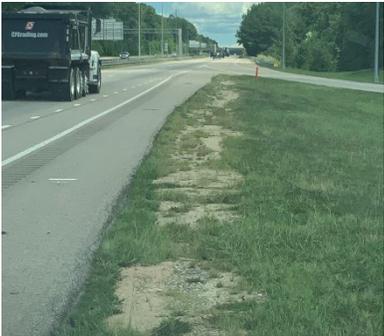
A17
2	Turf	TF_172	Bare Ground

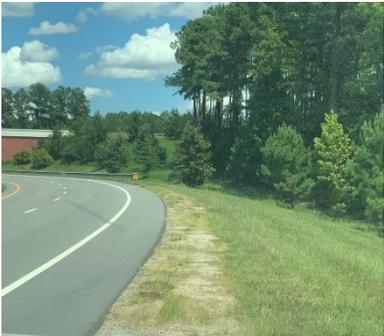
A24
3	Turf	TF_341	Bare Ground

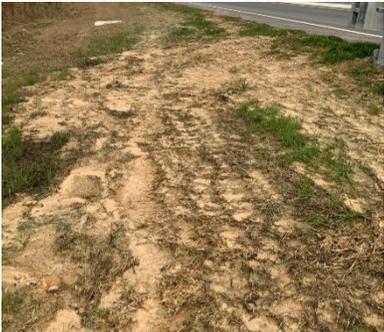
A32
6	Turf	TF_1061	Bare Ground
