# Maintenance Rating Program

## Triangle Expressway

February 2024

2023 Fourth Quarter Report

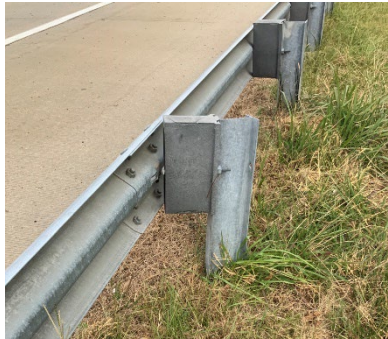
A10
3	Guardrail	BR_318	Twisted Post

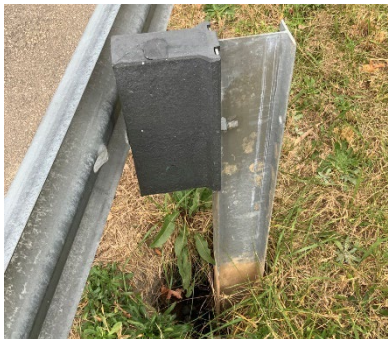
A1
4	Guardrail	BR_543	Twisted Post

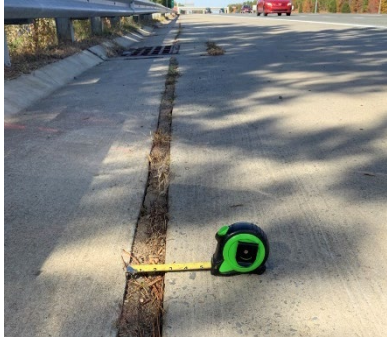
A1
2	Curb and Gutter	CG_191	Misalignment

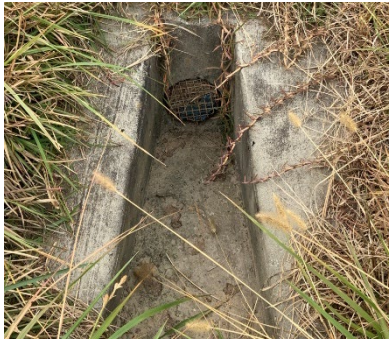
A13
2	Shoulder Drain	MDP_90	Obstruction

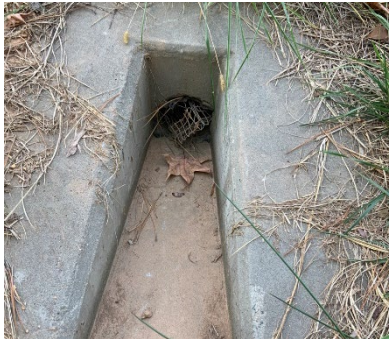
A17
3	Shoulder Drain	MDP_163	Rodent Screen

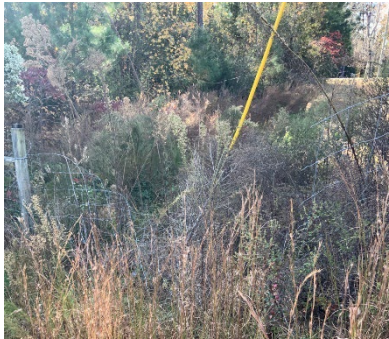
A26
2	Woven	FN_172	Hole

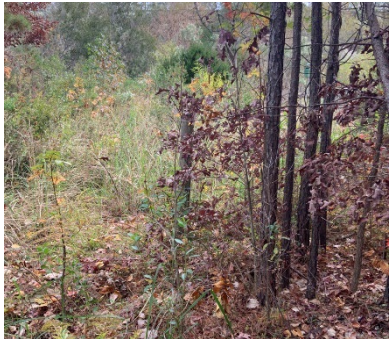
A8
3	Woven	FN_202	Hole

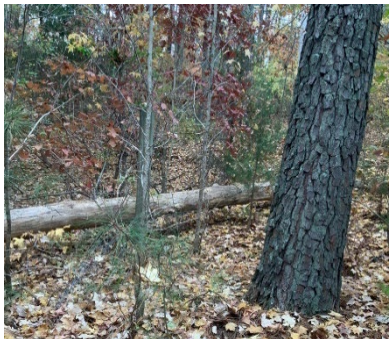
A3
4	Woven	FN_215	Height

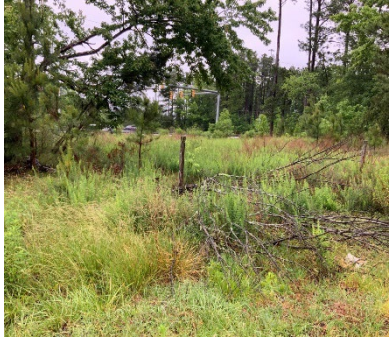
A30
6	Woven	FN_484	Hole

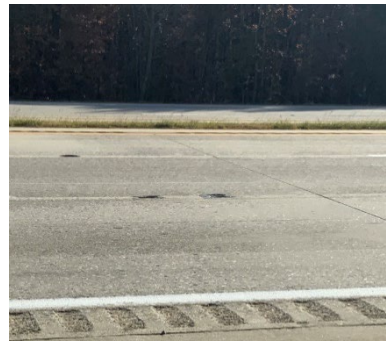
LS\_165

Pothole

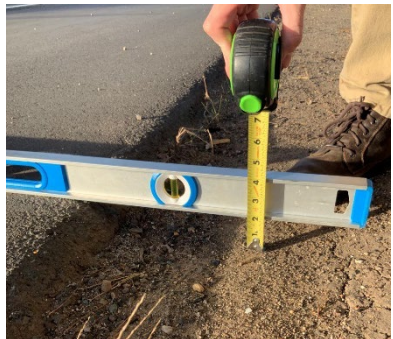
A17
2	Asphalt	LS_259	Drop off

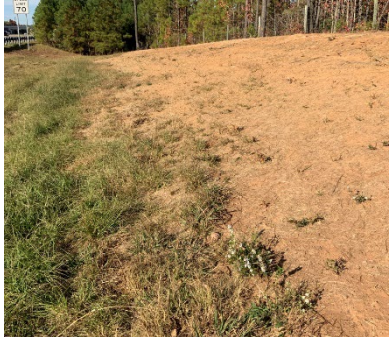
A23
2	Turf	TF_597	Bare Ground

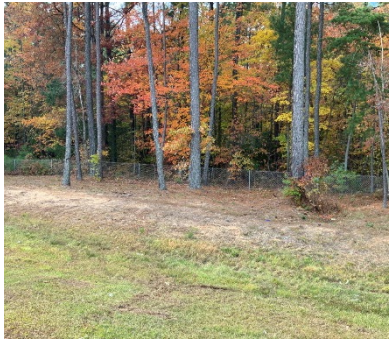
A11
3	Turf	TF_852	Bare Ground
