Maintenance Rating Program

Triangle Expressway

May 2024

2024 First Quarter Report

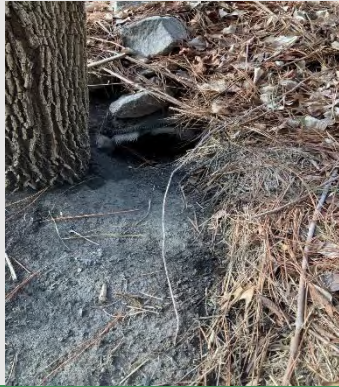
A26
2	Drain	DP_302	Obstruction

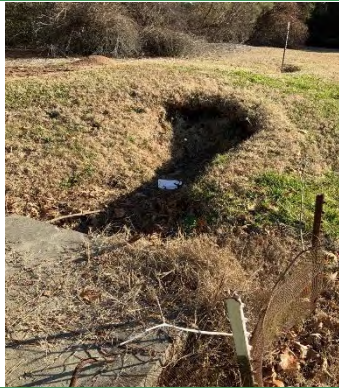
A6
3	Drain	DP_344	Erosion

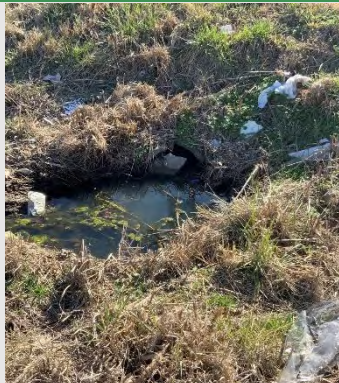
A31
4	Drain	DP_407	Obstruction

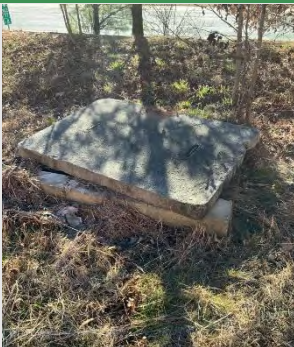
5	Drain	DP_786	Erosion	 	*ORA
6	Drain	DP_894	Other

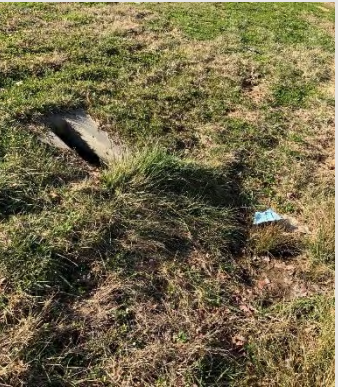
A11
2	Shoulder Drain	MDP_156	Obstruction

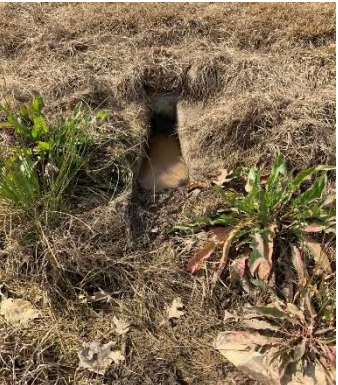
A25
3	Shoulder Drain	MDP_232	Obstruction

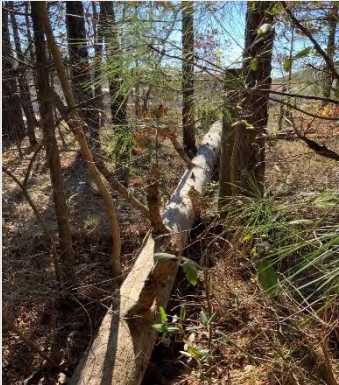
*ACZ
2	Woven	FN_22	Hole Height

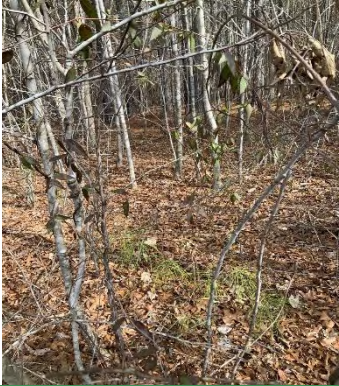
*ORA
3	Woven	FN_124	Hole Height

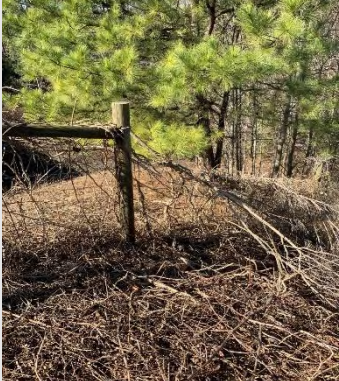
A12
4	Woven	FN_231	Hole Height

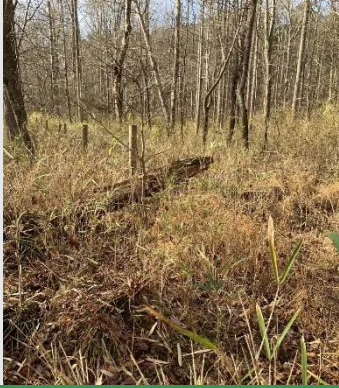
5	Woven	FN_297	Hole Height	 	A30
6	Woven	FN_395	Hole Height

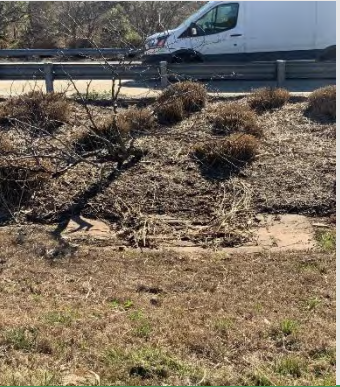
A30
2	Drop Inlet	IN_446	Obstruction

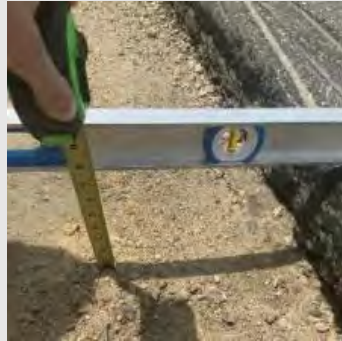
A13
2	Asphalt	LS_263	Drop off

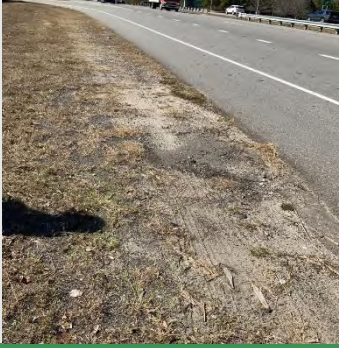
3	Asphalt	LS_563	Drop off

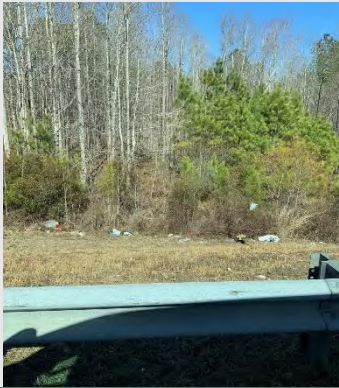
A20
2	Asphalt	LS_470	Litter

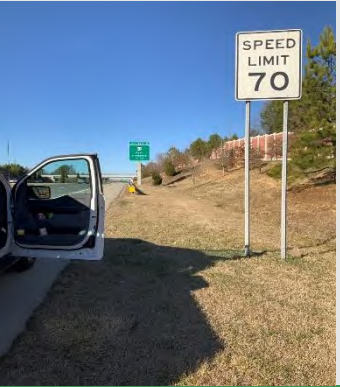
A30
2	Speed Limit	SN_700	Height

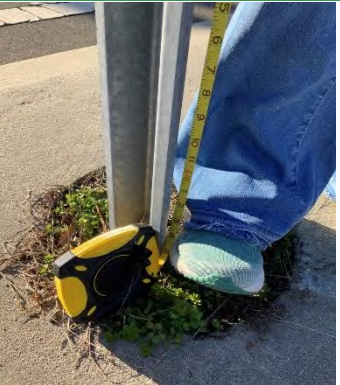
A5
3	Thru Traffic	SN_1033	Height

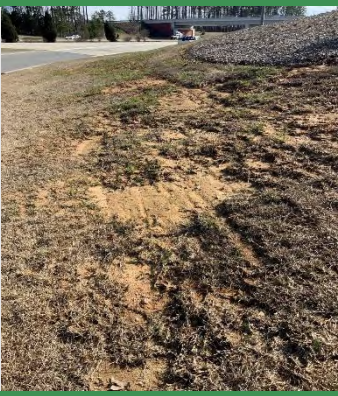
A30
6	Turf	TF_1069	Bare Ground
