# Maintenance Rating Program

## Triangle Expressway

2024 Second Quarter Report

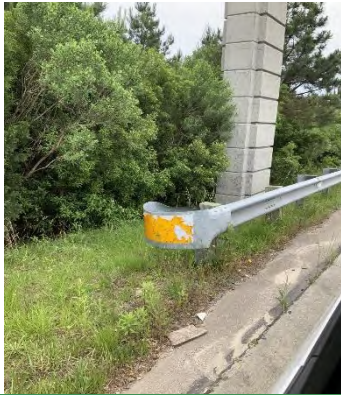
#	Material Type	Object ID	Failure Type	Photo	GIS Reference Page
1	Guardrail	BR_33	Damaged End Cap/ Reflectivity

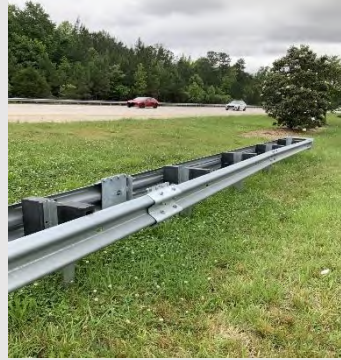
A27
2	Guardrail	BR_58	Missing Parts

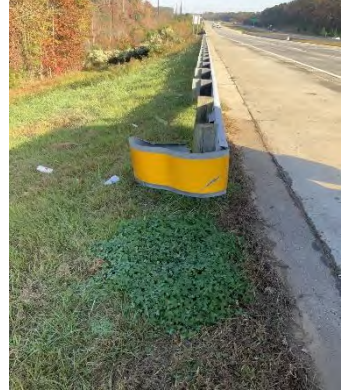
A8
3	Guardrail	BR_86	Damaged End Cap

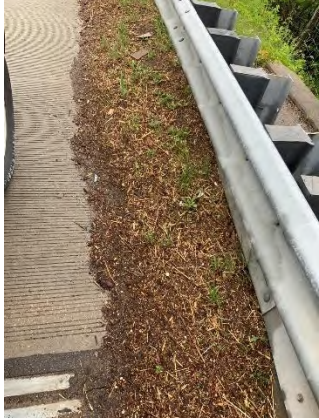
#	Material Type	Object ID	Failure Type	Photo	GIS Reference Page
1	Curb	CG_78	Settlement

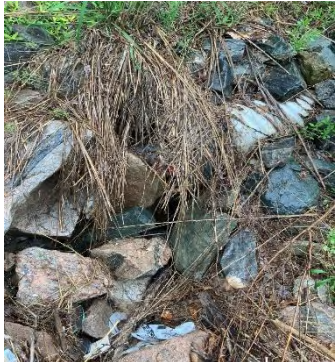
#	Material Type	Object ID	Failure Type	Photo	GIS Reference Page
1	Drain	DP_13	Obstruction

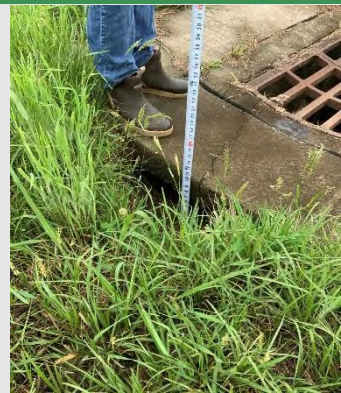
A27
2	Cross Pipe	DP_433	End Protection Damage

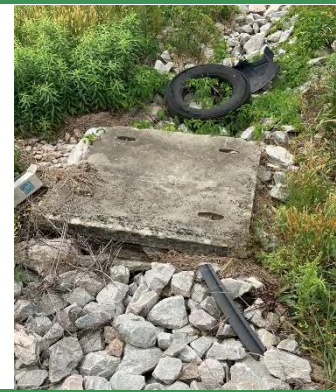
A4
3	Cross Pipe	DP_526	Obstruction

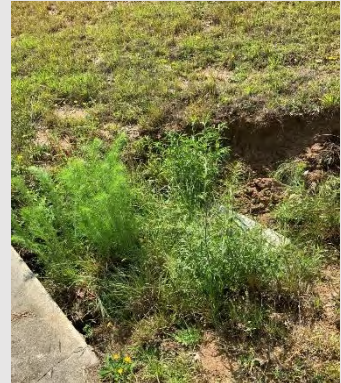
A1
4	Drain	DP_786	End Protection Damage

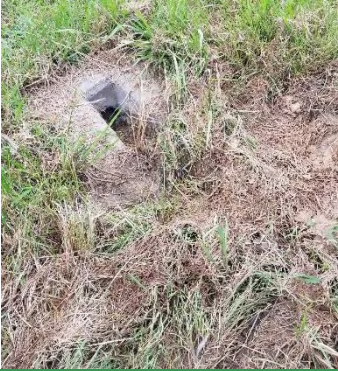
#	Material Type	Object ID	Failure Type	Photo	GIS Reference Page
1	Shoulder Drain	MDP_4	Obstruction

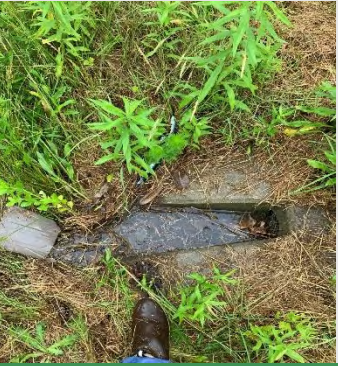
A6
2	Shoulder Drain	MDP_81	Obstruction

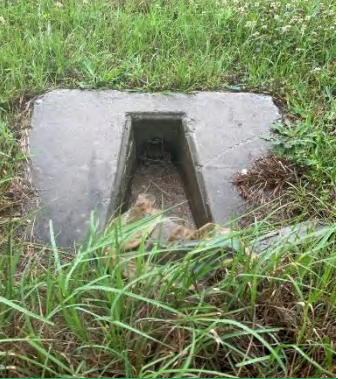
A16
3	Shoulder Drain	MDP_186	Obstruction

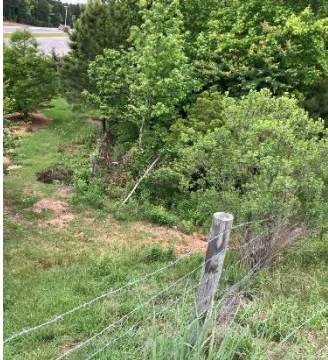
#	Material Type	Object ID	Failure Type	Photo	GIS Reference Page
1	Woven	FN_28	Fence Hole

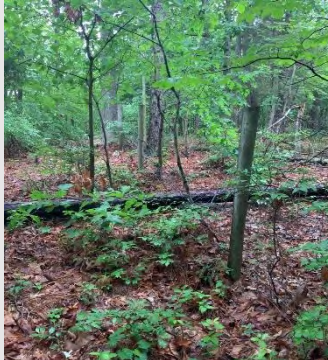
A26
2	Woven	FN_226	Hole Height

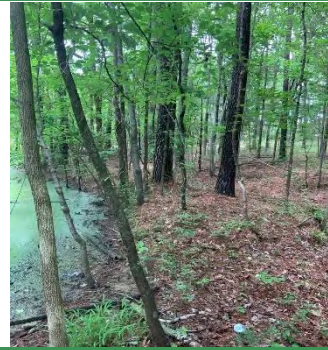
A33
3	Woven	FN_461	Fence Hole

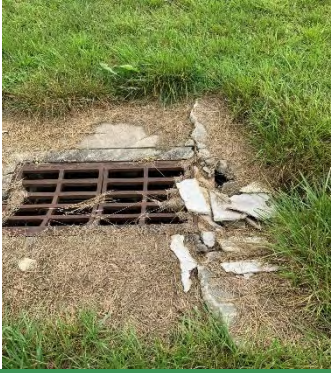
#	Material Type	Object ID	Failure Type	Photo	GIS Reference Page
1	Drop Inlet	IN_1	Eroded Area

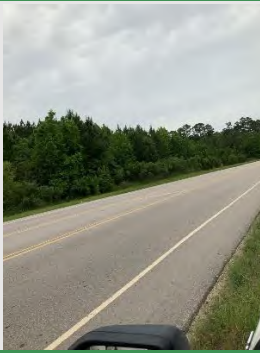
A26
2	Asphalt	LS_695	Nighttime Reflectivity

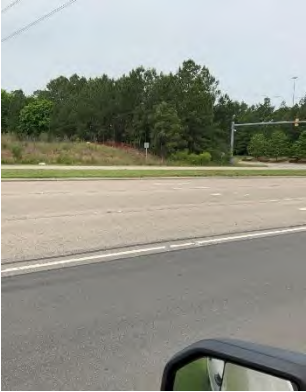
5	Thru Lane	PS_442	Daytime Assessment / Nighttime Reflectivity

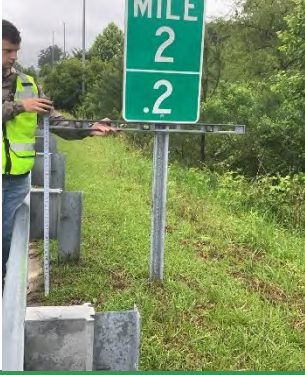
#	Sign Type	Object ID	Failure Type	Photo	GIS Reference Page
1	Mile Post	SN_626	Height Requirement

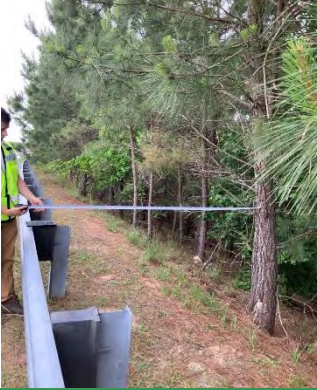
#	Material Type	Object ID	Failure Type	Photo	GIS Reference Page
1	Tree & Brush	TB_130	Barrier Clearance

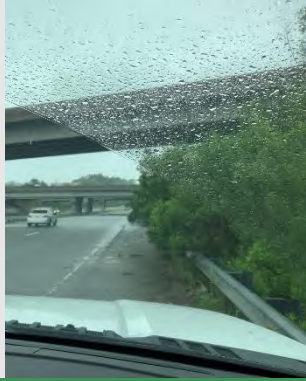
A25
2	Tree & Brush	TB_417	Barrier Clearance

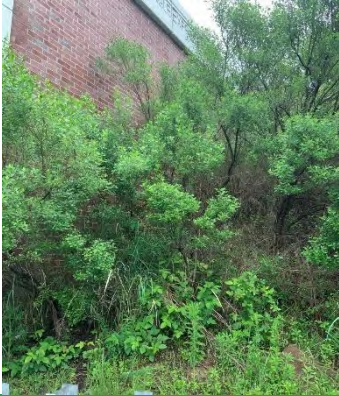
#	Material Type	Object ID	Failure Type	Photo	GIS Reference Page
1	Bridge Wall	WL_10	Vegetation

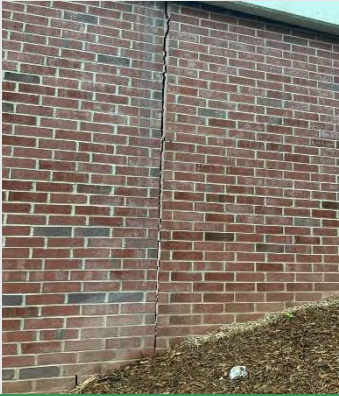
A31
2	Bridge Wall	WL_11	Unsealed Cracks/Joints

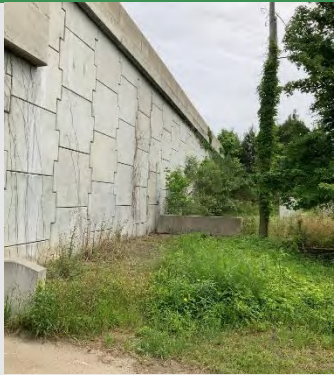
4	Bridge Wall	WL_39	Vegetation
