Maintenance Rating Program

Triangle Expressway

November 2024

2024 Third Quarter Report

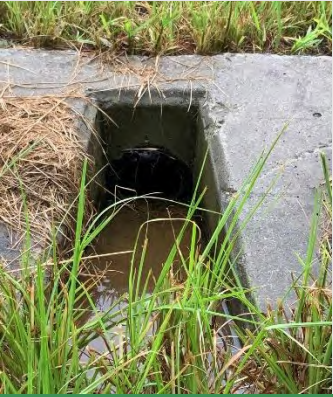
A20
2	Shoulder Drain	MDP_158	Rodent Screen

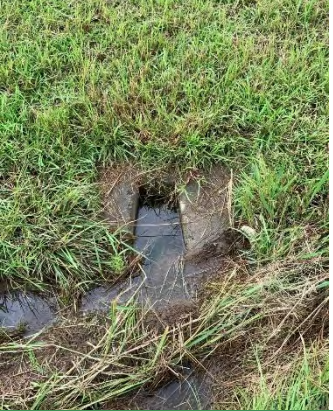
A25
3	Shoulder Drain	MDP_225	Obstruction

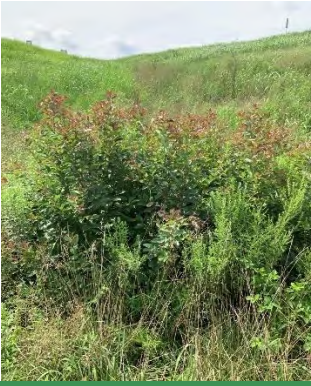
A2
2	Drop Inlet	IN_481	Obstruction

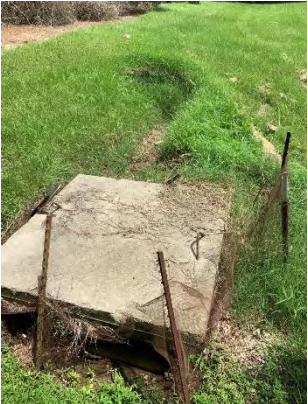
A1
3	Drop Inlet	IN_518	Eroded Area

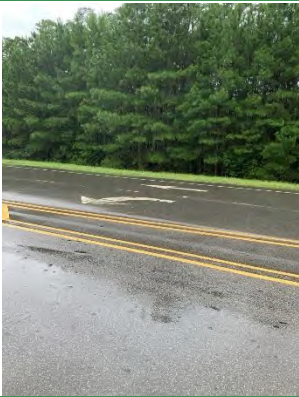
*ORA
2	Only	PS_425	Daytime Assessment / Nighttime Reflectivity	No Photo Provided	*ORA
3	Left Turn	PS_585	Nighttime Reflectivity

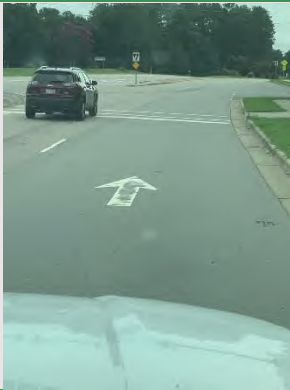
A26
4	Thru Lane	PS_625	Daytime Assessment / Nighttime Reflectivity
