NORTH CAROLINA
Turnpike Authority

Maintenance Rating Program

Triangle Expressway

2019 Second Quarter Report

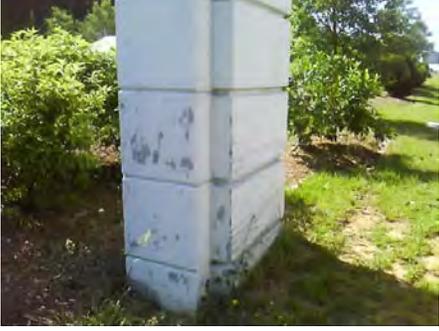
A11
2	Gantry Support	DS_46	Paint Scaling

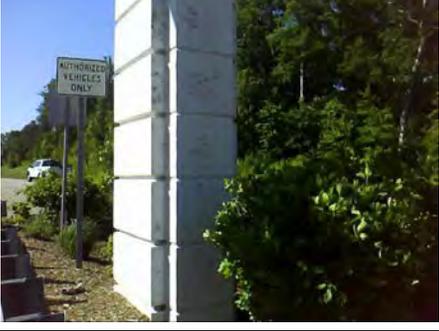
A6
4	Gantry Support	DS_159	Paint Scaling

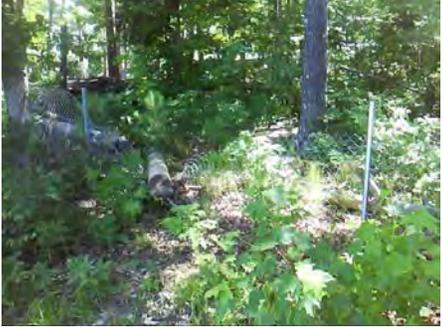
A2
2	Woven	FN_292	Fence Height

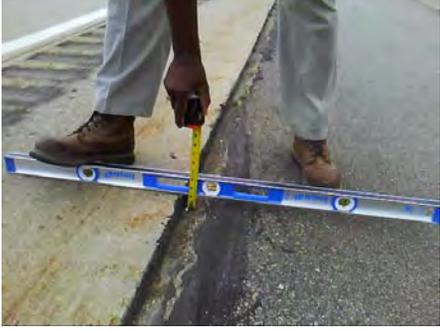
A11
2	Concrete	LS_156	Paved Shoulder Drop-Off

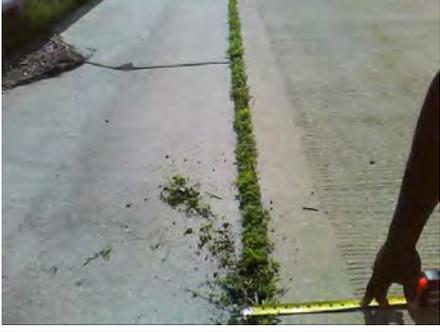
A12
3	Concrete	LS_318	Paved Shoulder Joint Separation

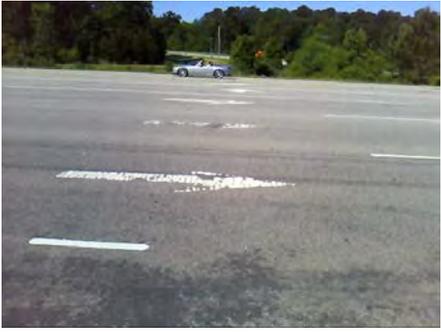
A7
4	Thru Arrow	PS_459	Daytime Assessment

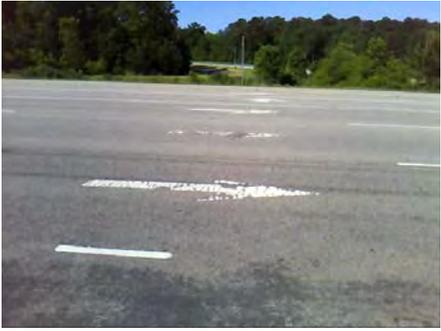
A7
5	Thru Arrow	PS_460	Daytime Assessment

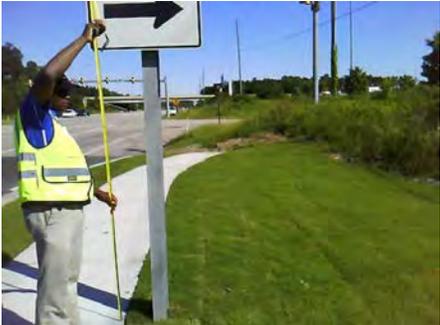
A13
2	NC Route	SN_334	Height Requirement

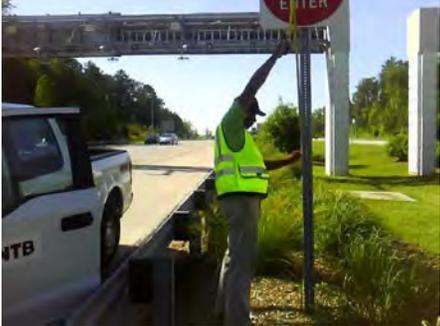
A7
3	Do Not Enter	SN_690	Height Requirement

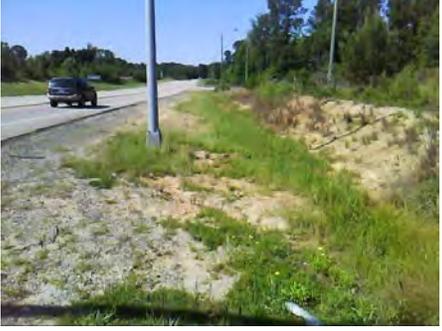
A18
2	Turf	TF_271	Bare Ground

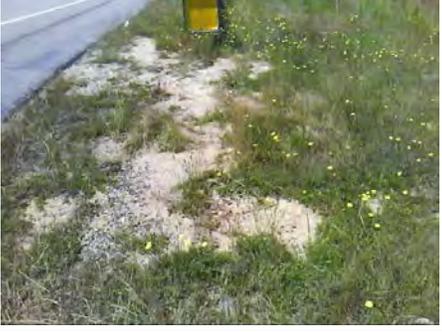
A24
3	Turf	TF_378	Bare Ground

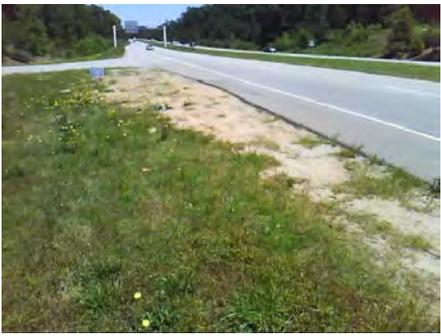
A32
6	Turf	TF_457	Bare Ground

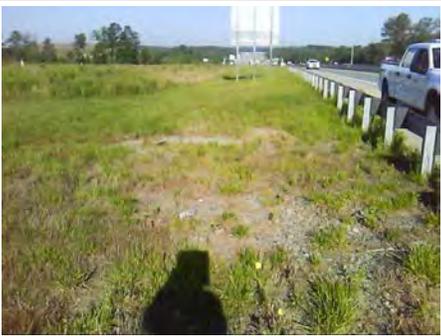
A32
7	Turf	TF_467	Bare Ground

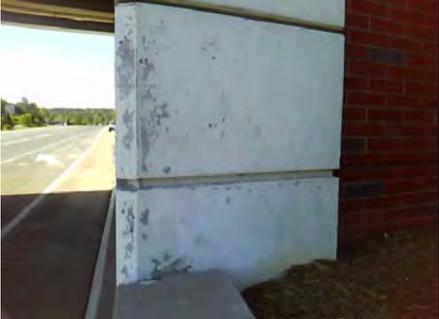
A38
2	Bridge Wall	WL_42	Paint Scaling
