NORTH CAROLINA
Turnpike Authority

Maintenance Rating Program

Triangle Expressway

2017 First Quarter Report

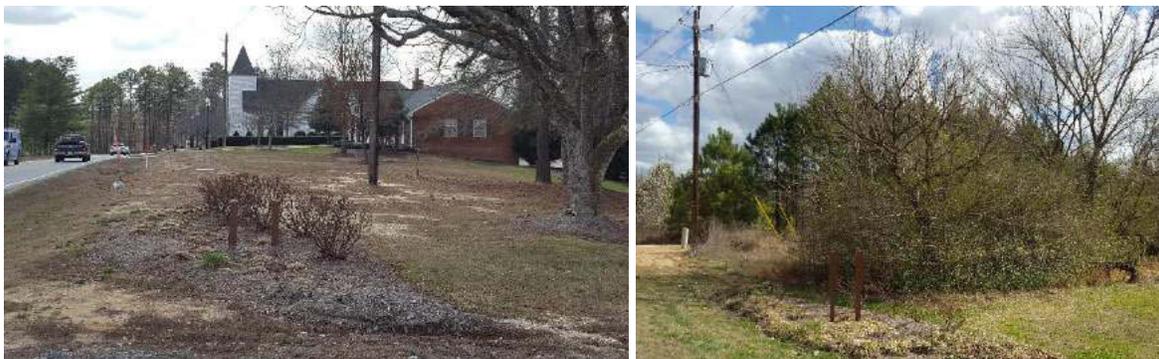
Figure 7: Green Level West Historic District Signs, Landscape Areas

As part of each quarterly inspection, assessors visit the four Green Level Historic District signs to conduct a visual inspection of each sign and ensure they are in good standing. During this quarter, the sign located near the intersection of Green Level Church Road and Green Level West Road was excluded from the inspection inventory due to inaccessibility to the sign because of construction work in the area. The three signs included in the inspection inventory were only inspected for landscape appearance because two of the three signs were vandalized and the other sign was temporarily removed to be used as a sample to replace the vandalized signs. All landscaped areas at the location of the signs were found to be well maintained (**Figure 7**). NCTA is in the process of replacing all signs.

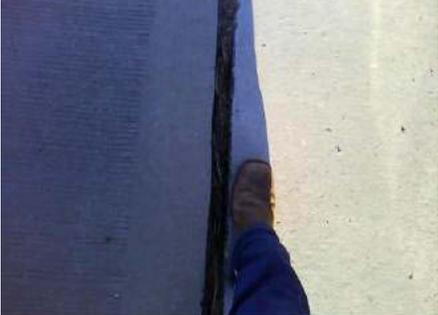
A15
2	Valley	CG_163	Misalignment

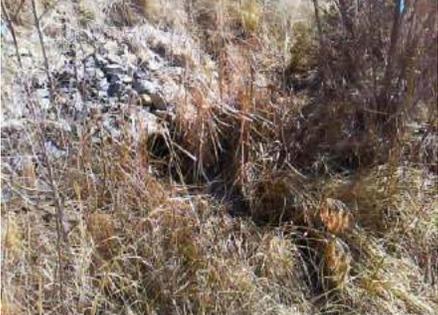
A3
2	Drain	DP_972	End Treatment Damage

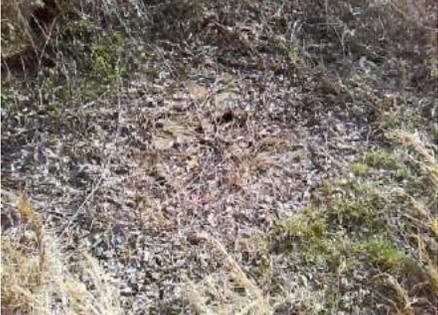
A28
3	Culvert	DP_1025	Obstruction

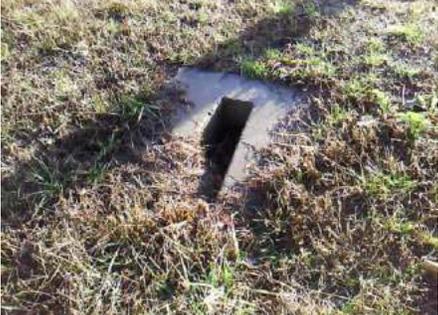
A44
2	Shoulder Drain	MDP_13	Obstruction, Grate Damage

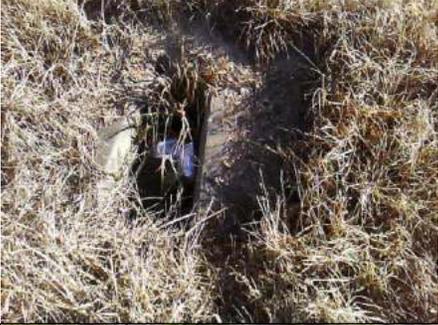
A12
3	Shoulder Drain	MDP_26	Obstruction

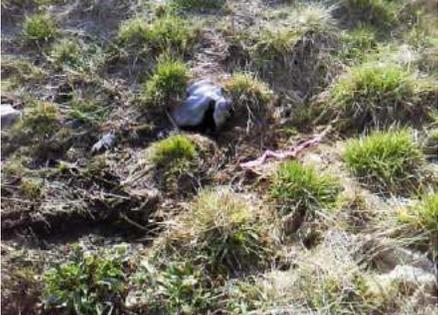
A14, A15
4	Shoulder Drain	MDP_39	Obstruction

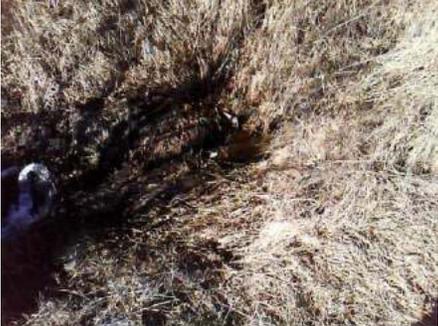
#	Material Type	Object ID	Failure Type	Photo	GIS Reference Page
5	Shoulder Drain	MDP_58	Obstruction

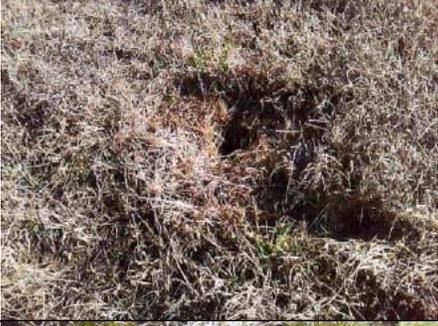
A20, A21
6	Shoulder Drain	MDP_63	Obstruction

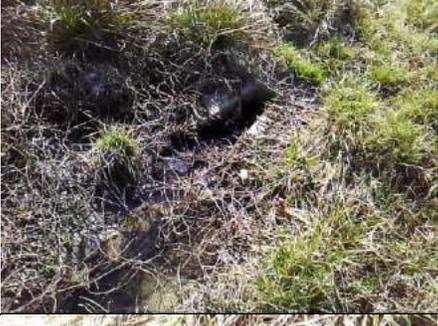
A21
7	Shoulder Drain	MDP_77	Obstruction

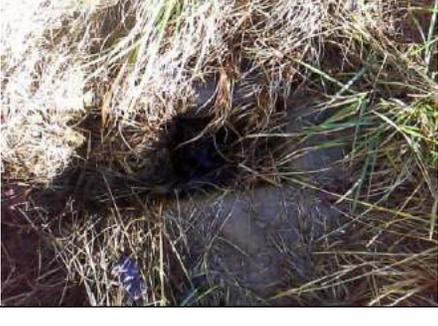
A24
8	Shoulder Drain	MDP_85	Obstruction

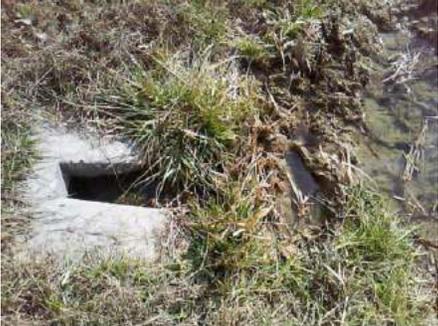
#	Material Type	Object ID	Failure Type	Photo	GIS Reference Page
9	Shoulder Drain	MDP_102	Grate Damage

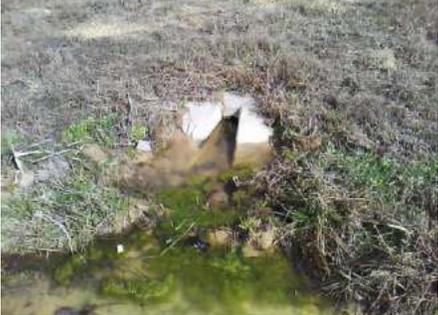
A30
10	Shoulder Drain	MDP_104	Erosion

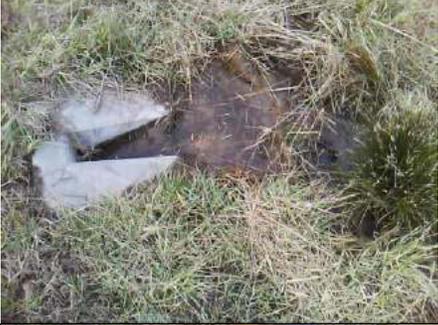
A30
11	Shoulder Drain	MDP_116	Obstruction

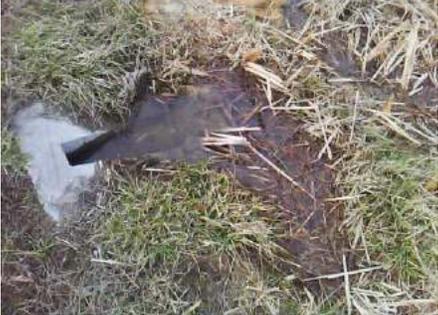
A31, A32
12	Shoulder Drain	MDP_150	Obstruction

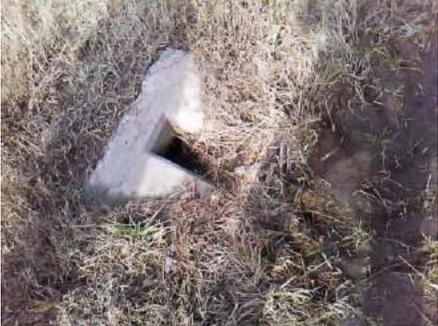
#	Material Type	Object ID	Failure Type	Photo	GIS Reference Page
13	Shoulder Drain	MDP_178	Obstruction

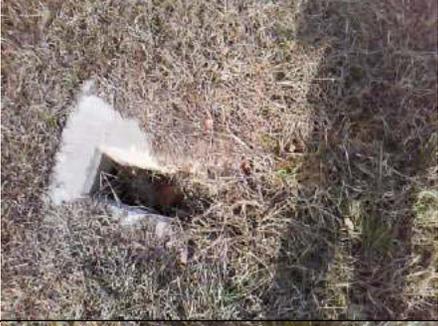
A48
14	Shoulder Drain	MDP_179	Obstruction

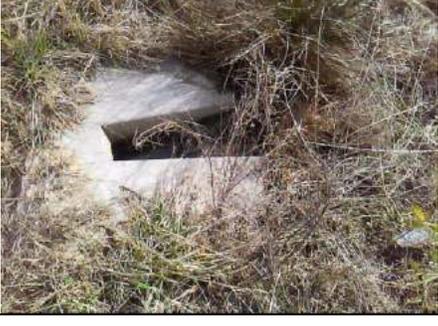
A43
15	Shoulder Drain	MDP_182	Obstruction

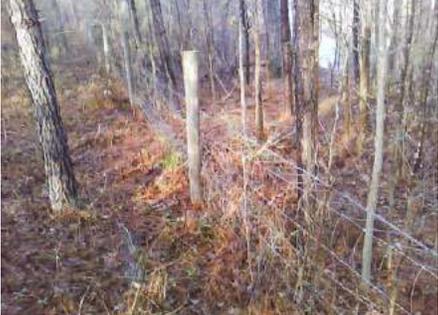
A10
2	Woven	FN_7	Fence Height, Hole Height

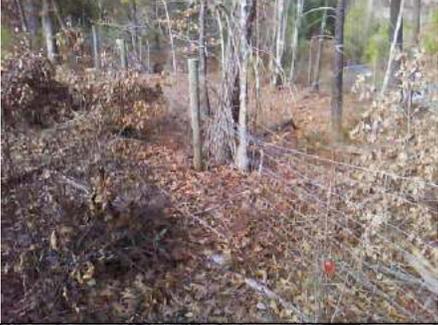
A10
3	Woven	FN_169	Fence Height

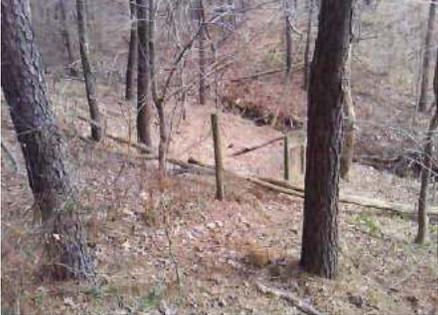
A5
4	Woven	FN_171	Fence Height

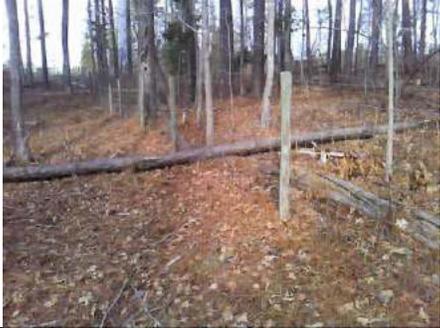
#	Material Type	Object ID	Failure Type	Photo	GIS Reference Page
5	Woven	FN_173	Fence Height

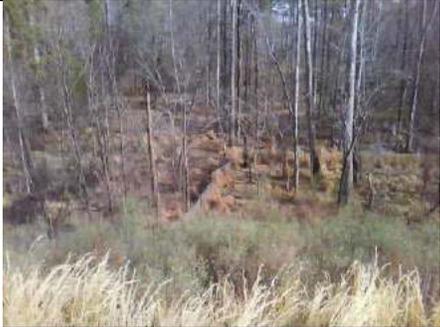
A48
6	Chain Link	FN_247	Opened Gate

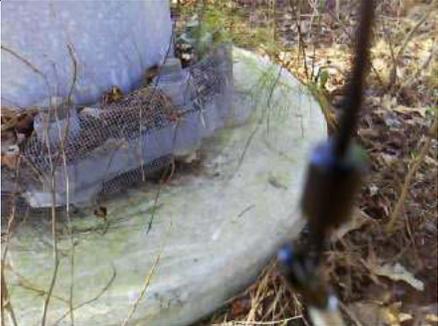
#	Material Type	Object ID	Failure Type	Photo	GIS Reference Page
1	High Mast	HL_2	Functional Damage	Not Available for Nighttime Failure.	A10, A11
2	High Mast	HL_3	Functional Damage	Not Available for Nighttime Failure.	A10, A11
3	Single Roadway	HL_11	Functional Damage	Not Available for Nighttime Failure.	A11
4	High Mast	HL_26	Part Damage

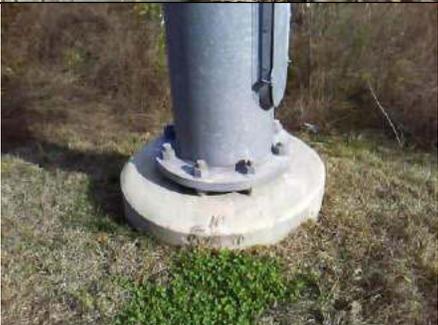
A21
5	High Mast	HL_90	Part Damage

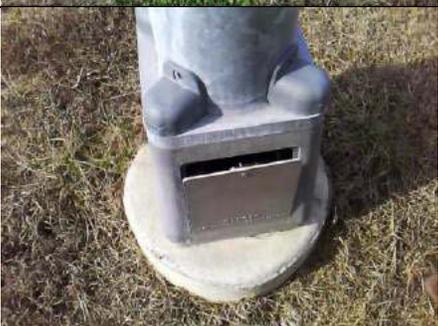
A45
6	Single Roadway	HL_162	Part Damage

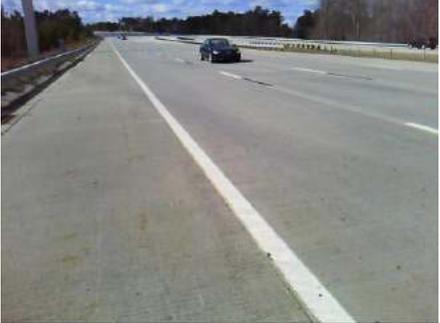
A48
2	Concrete	LS_339	Rumble Strips

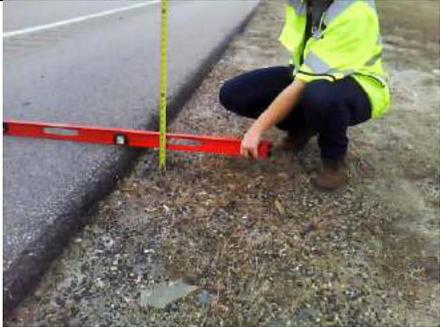
A22
2	Asphalt	LS_381	Shoulder Drop Off

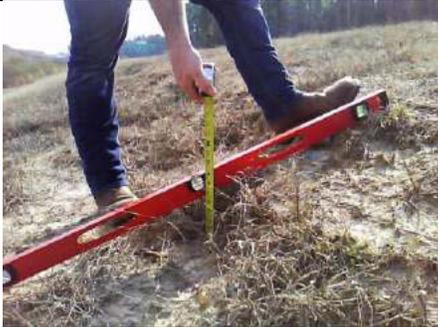
A24
2	Asphalt	LS_277	Slope Failure

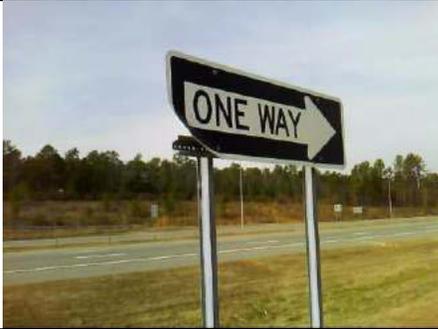
A20
2	One Way	SN_327	Surface Damage

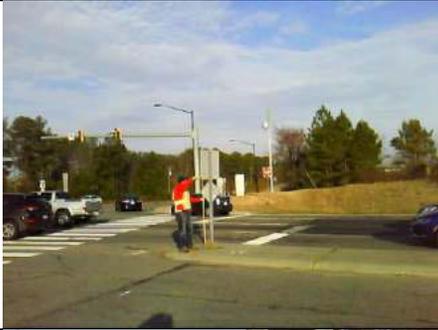
A44
3	Keep Right of Median	SN_494	Height Requirement

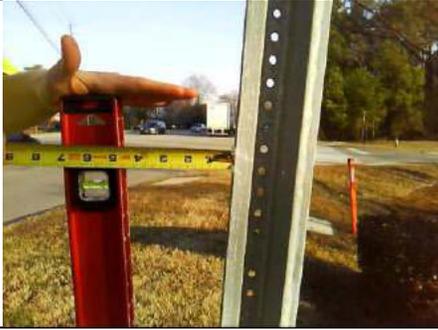
A3
4	Trailblazer	SN_1005	Leaning

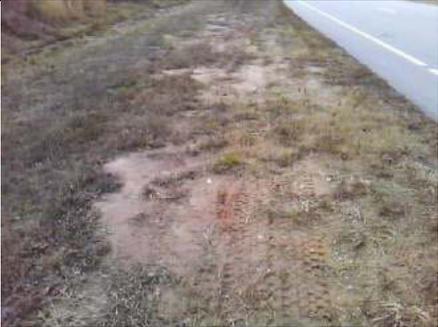
A41
2	Turf	TF_22	Bare Ground

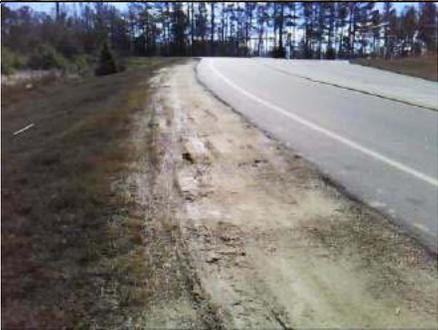
A11
3	Turf	TF_26	Bare Ground

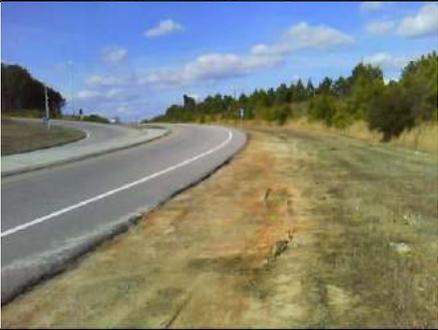
A21
4	Turf	TF_81	Bare Ground

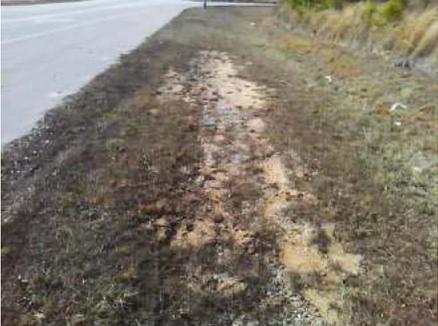
#	Material Type	Object ID	Failure Type	Photo	GIS Reference Page
5	Turf	TF_83	Bare Ground

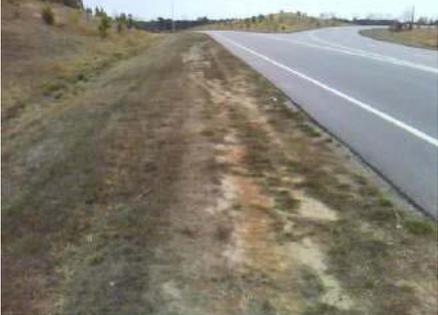
A29
6	Turf	TF_138	Bare Ground

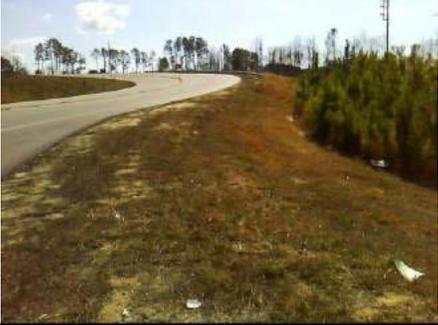
A40
7	Turf	TF_165	Bare Ground

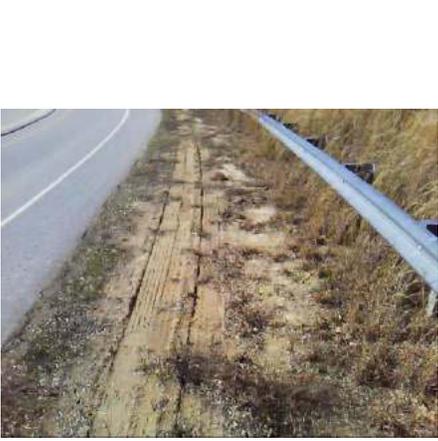
A28
8	Turf	TF_166	Bare Ground

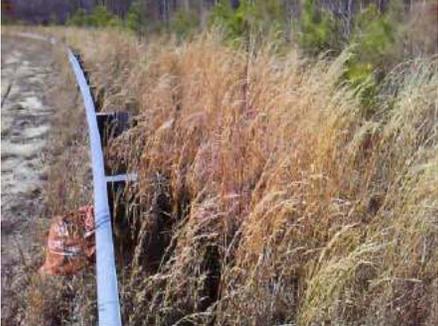
#	Material Type	Object ID	Failure Type	Photo	GIS Reference Page
8	Turf	TF_166	Height

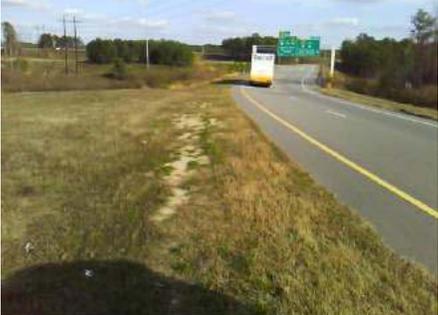
A28
9	Turf	TF_172	Bare Ground

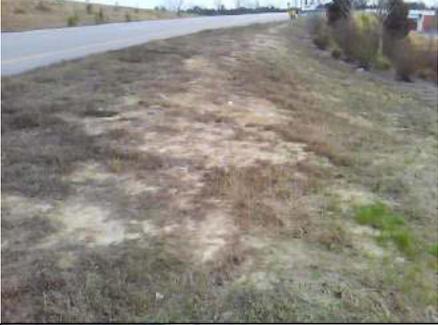
A39
10	Turf	TF_374	Bare Ground

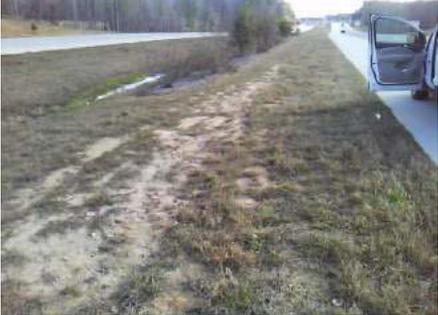
A40
11	Turf	TF_446	Bare Ground

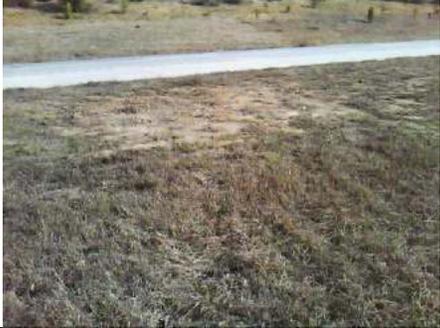
#	Material Type	Object ID	Failure Type	Photo	GIS Reference Page
12	Turf	TF_491	Bare Ground

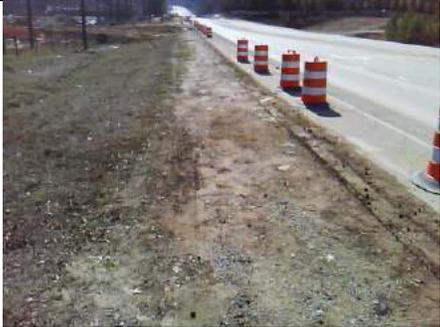
A31
13	Turf	TF_500	Bare Ground

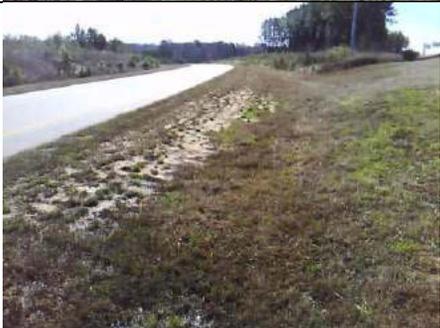
A30
14	Turf	TF_519	Bare Ground

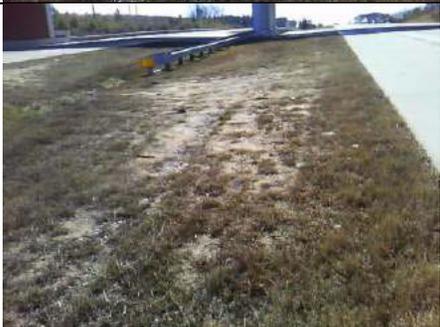
A27
15	Turf	TF_539	Bare Ground

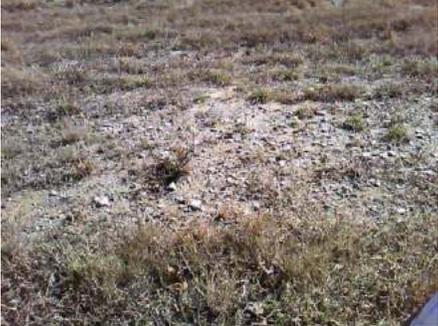
#	Material Type	Object ID	Failure Type	Photo	GIS Reference Page
16	Turf	TF_543	Bare Ground

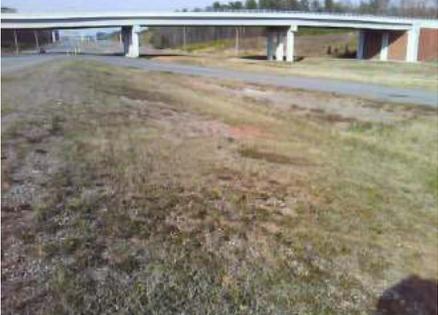
A26
17	Turf	TF_979	Bare Ground

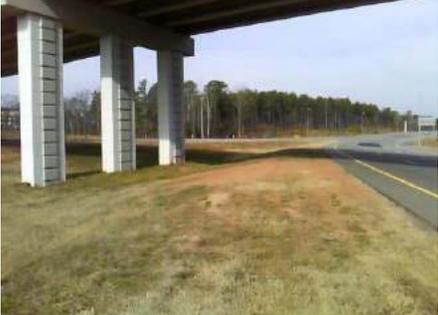
A48
18	Turf	TF_985	Bare Ground
