NORTH CAROLINA
Turnpike Authority

Maintenance Rating Program

Triangle Expressway

2017 Third Quarter Report

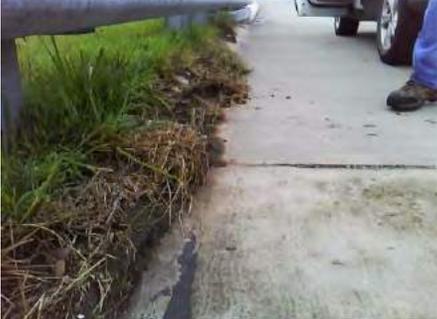
A21
2	Valley	CG_66	Obstruction

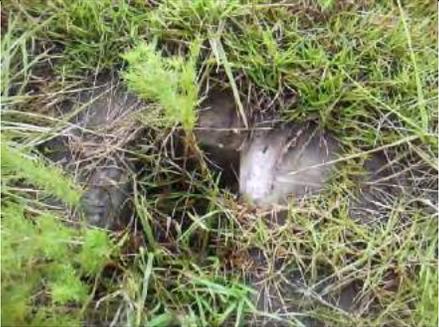
A photograph of a shoulder drain opening surrounded by tall green grass. The drain is almost completely blocked by a thick layer of dry, tangled vegetation and debris.	A16
3	Shoulder Drain	MDP_34	Obstruction, Erosion

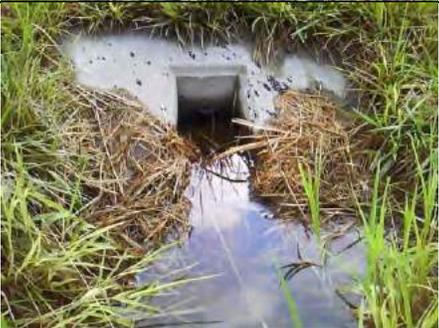
A photograph showing a shoulder drain opening. The drain is heavily obstructed by dry vegetation. There is significant erosion around the drain, with a deep, narrow channel of water flowing through the debris and soil.	A17
4	Shoulder Drain	MDP_43	Obstruction

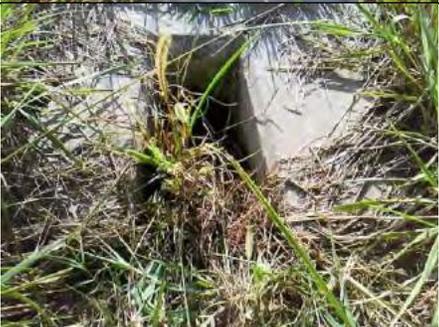
A photograph of a shoulder drain opening. The drain is blocked by a large pile of dry, brown vegetation and debris, with some water pooling around the opening.	A18

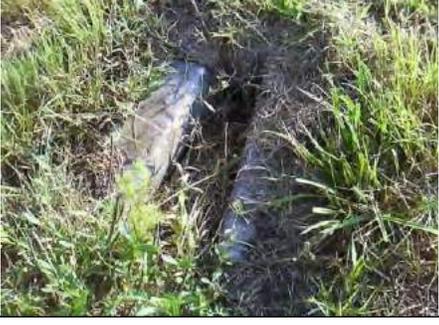
A36
8	Shoulder Drain	MDP_144	Obstruction

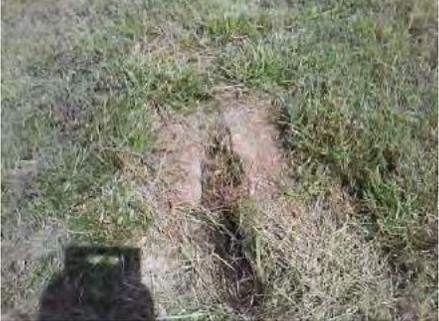
A37
10	Shoulder Drain	MDP_154	Obstruction

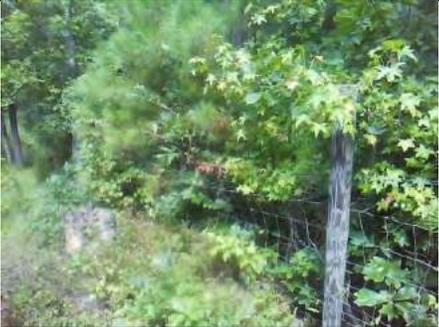
A9
2	Woven	FN_177	Fence Height

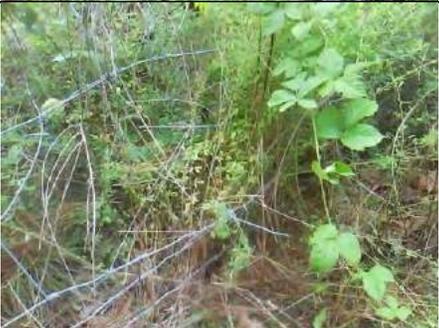
A10
3	Woven	FN_181	Fence Height

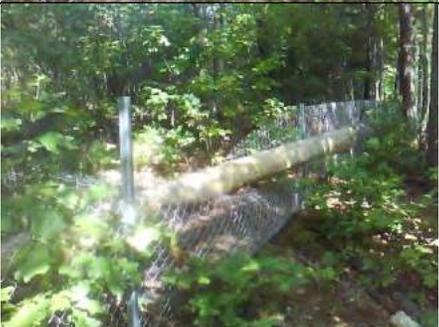
A10
4	Chain Link	FN_204	Fence Height

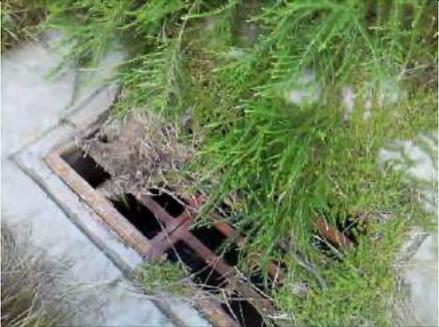
A25
2	Inlets	IN_26	Obstruction

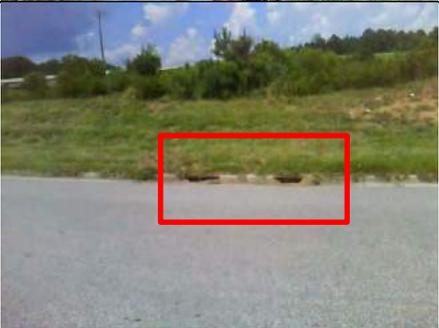
A24
3	Inlets	IN_173	Obstruction

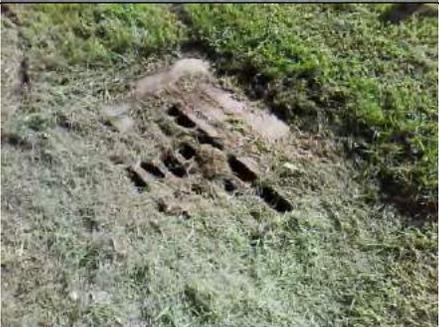
A11
4	Inlets	IN_366	Obstruction

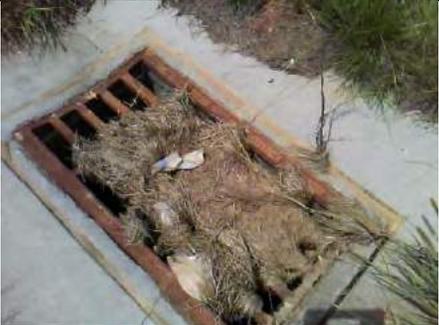
A8
6	Inlets	IN_594	Obstruction

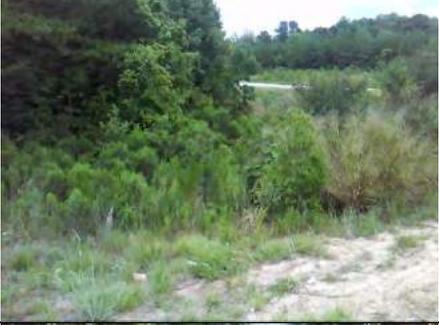
A35
2	Plant Bed	PB_261	Health, Weeds

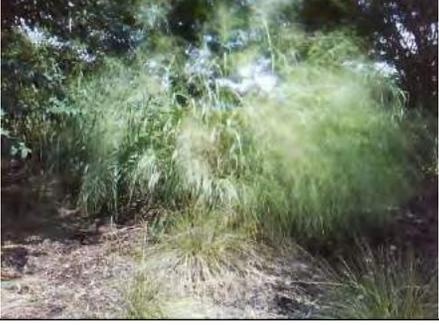
A44
3	Plant Bed	PB_298	Health

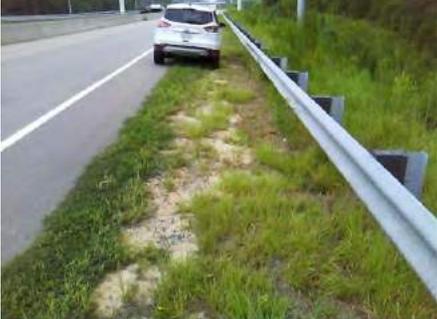
A27
2	Turf	TF_140	Bare Ground

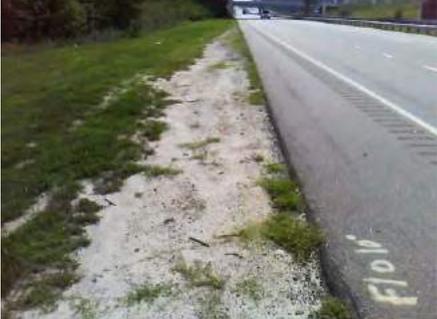
A40
3	Turf	TF_189	Bare Ground

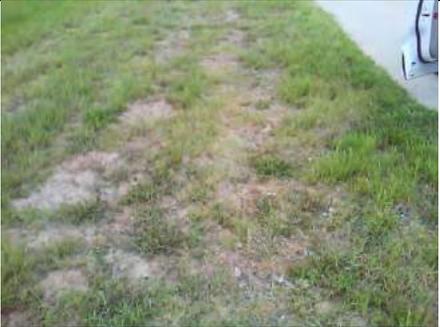
A44
6	Turf	TF_327	Bare Ground

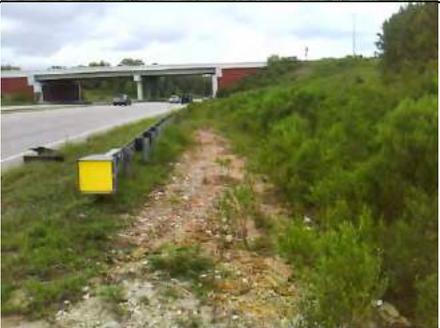
A42
7	Turf	TF_454	Bare Ground

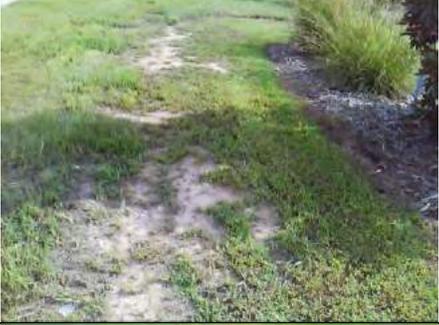
A44, A45
10	Turf	TF_643	Bare Ground

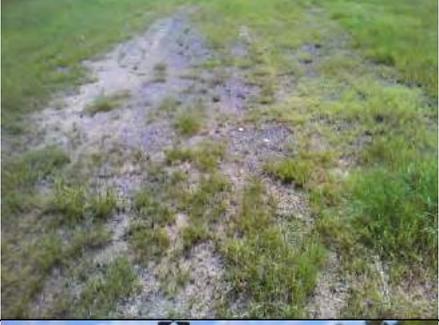
A15
11	Turf	TF_791	Bare Ground

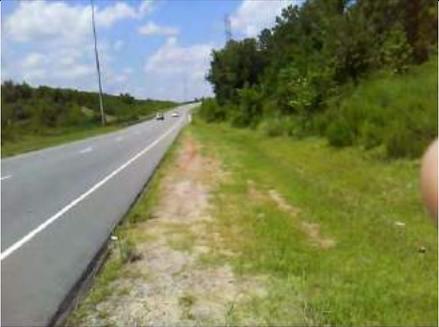
A50, A51
14	Turf	TF_909	Bare Ground

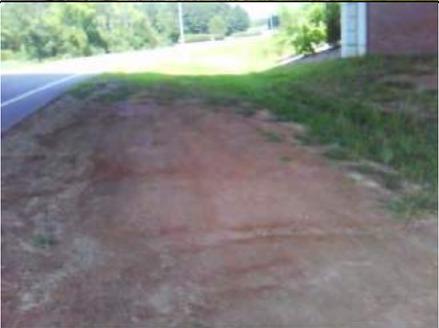
A50
15	Turf	TF_963	Bare Ground

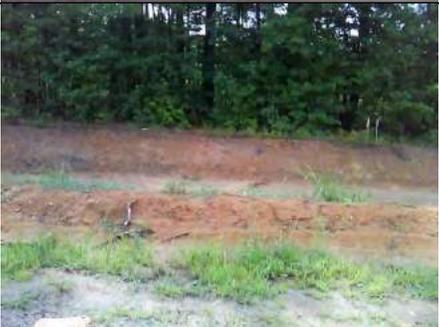
A46
16	Turf	TF_1006	Bare Ground

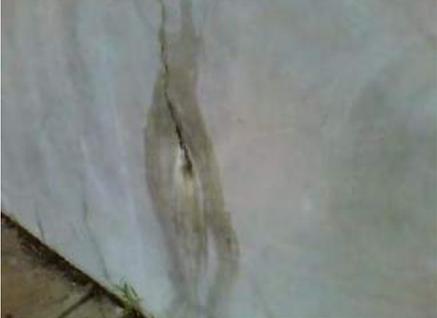
A46
2	MSE Wall	WL_32	Paint Scaling

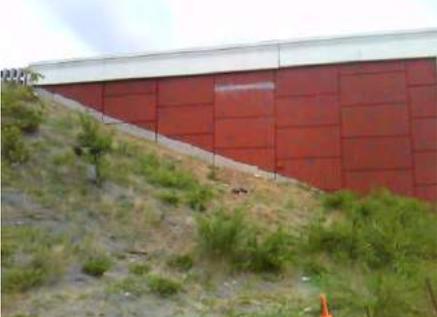
A11
3	MSE Wall	WL_72	Paint Scaling
