NORTH CAROLINA
Turnpike Authority

Maintenance Rating Program

Triangle Expressway

2018 Second Quarter Report

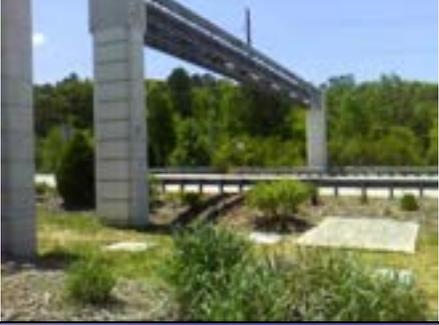
A20
2	Gantry Support	DS_45	Paint Scaling

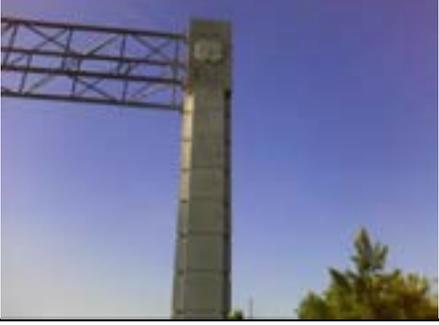
A20
3	Overhead Sign Support	DS_246	Paint Scaling

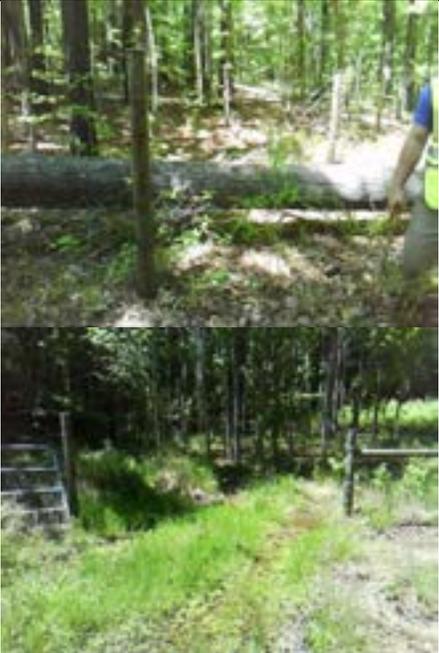
A49
2	Woven	FN_396	Fence Height, Hole Height, Open Gate

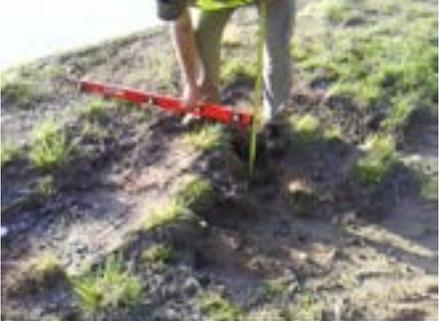
A46
2	Concrete	LS_134	Slope Deviation

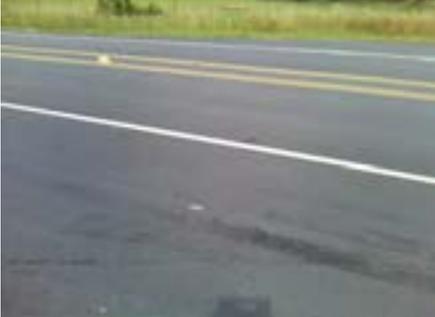
#	Material Type	Object ID	Failure Type	Photo	GIS Reference Page
1	Asphalt	LS_10	Missing Markers

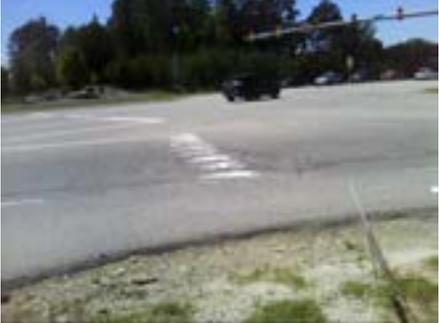
A57
3	Yield	PS_449	Nighttime Reflectivity, Daytime Assessment

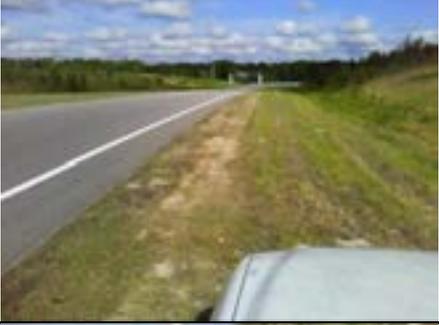
A8
2	Turf	TF_136	Bare Ground

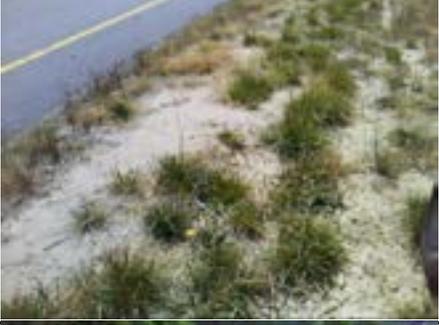
A39, A40, A43
3	Turf	TF_170	Bare Ground

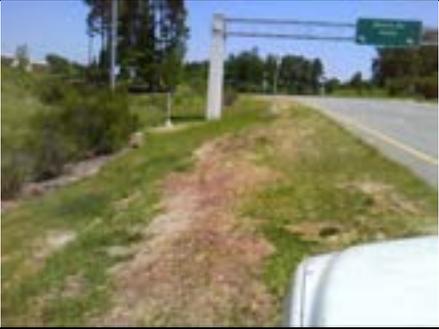
A28, A29
6	Turf	TF_266	Bare Ground

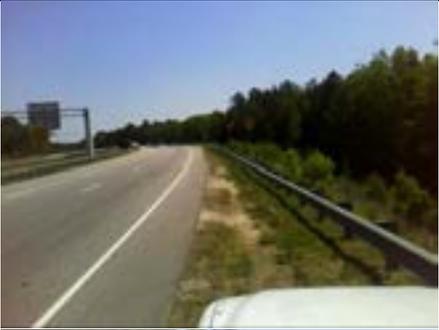
A57
7	Turf	TF_292	Bare Ground

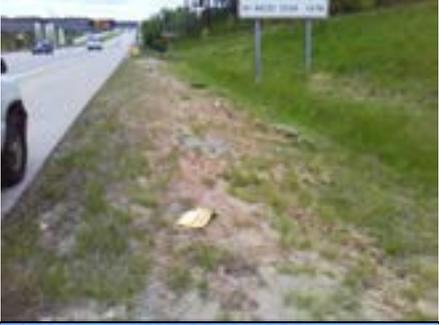
A26, A27
10	Turf	TF_585	Bare Ground

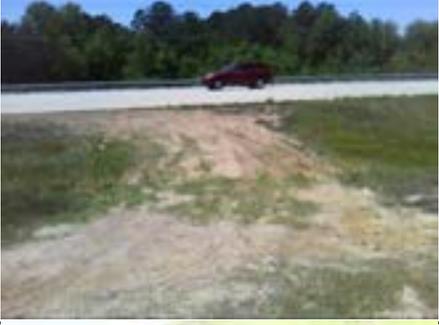
A20
11	Turf	TF_589	Bare Ground

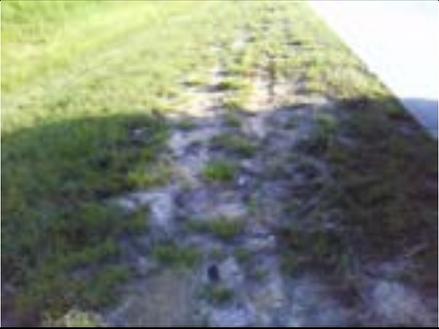
A18, A19
14	Turf	TF_623	Bare Ground

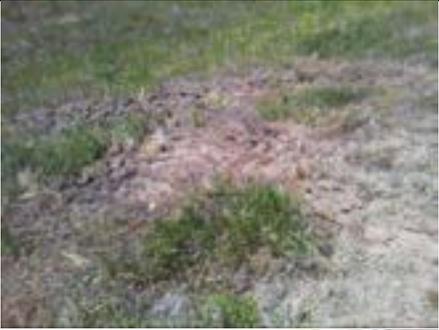
A16
15	Turf	TF_658	Bare Ground

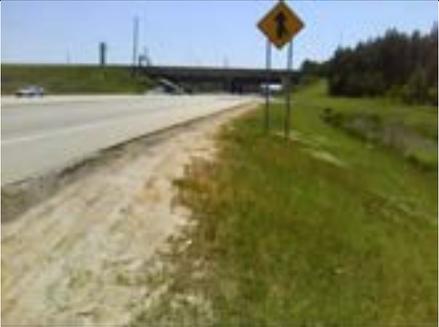
A58, A59
18	Turf	TF_991	Bare Ground

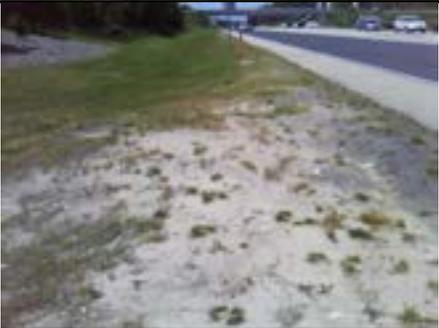
A10, A11
19	Turf	TF_993	Bare Ground
